**STEAM TUGBOAT EXPLOSION.**

BY S. N. HARTWELL.

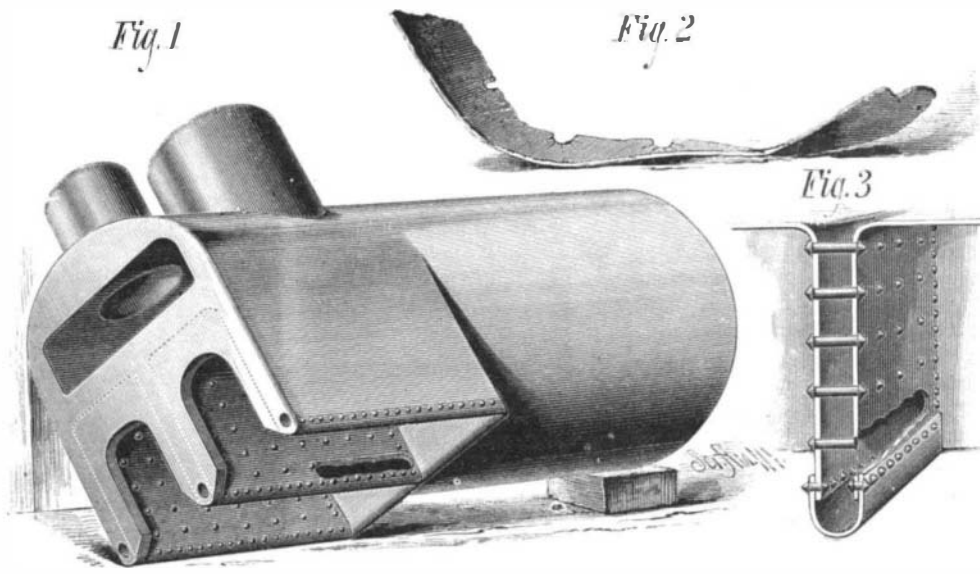
**BOILER EXPLOSION.**

The sketches which I herewith submit are intended to illustrate the accident, if a blow-out may be so designated, that happened to the boiler of the steam tug Jacob Brandow, in the lower bay of New York, on the 2d of June. The perspective sketch (Fig. 1) represents the boiler lying on its side, which position has no reference to the effect of the blow-out, but it is so placed for the purpose of showing the location of the rupture and its relation to adjacent parts of the boiler. It will be seen that the boiler is of the double furnace tugboat type, a variation of the fire-box form common in the towing practice of this city and vicinity. Its principal dimensions are: Diameter, 7 feet; length, 15 feet; dome, 4 feet diameter by 5 feet high. Two furnaces, each 34½ by 72 inches horizontal measurement; height above grates, about 30 inches. There are 10 flues, 5 to each furnace, through which the gases pass directly forward to the smoke connection, whence they return by 75 tubes to the up-take (or front connection) and chimney. The flues first mentioned are to each furnace: one 12 inches, three 8 inches, and one 7 inches diameter. The boiler was made of five-sixteenth iron plates, by a reputable city manufacturer, in 1867, since when, about seventeen months ago, it was fitted with new furnace sides and put in thorough repair. The workmanship and material appear to be the best. No stamp indicating the tensile quality of the iron was observed, however, upon the plates. The steam pressure allowed by the government certificate is 65 pounds by the gauge; and there was one common lever safety valve, by which steam was supposed to escape when the limit of pressure was reached.

About 6:30 P.M. on the 2d of June, while steaming at the usual working pressure—something less than 65 lb.—a piece of one of the new sides blew out, apparently starting at the point *a* Figs. 1 and 2, where the iron is now but about half its original thickness, namely 0.155 (originally 0.312). The sketch, Fig. 2, gives an idea of its proportion and present shape. At other points, as *b* and *c*, the thickness is respectively 0.185 and 0.165 inch. On the side, *e*, at the margin of the piece, is observed the peculiar defect called *star corrosion*, indicated by radiating lines at the stay holes. This condition is often found on the water side of stayed flat surfaces that have been subjected to a sufficient pressure to puff the plates between the stays, giving it the appearance (in less degree) of a mattress. This has the effect of opening the texture of the plate around the stay hole, which goes and comes as the pressure falls and rises; radial lines of corrosion are formed, deepening and widening toward the hole with each successive motion, till leaks and finally ruptures occur. When there is a considerable area of overloaded plate stayed insufficiently, one stay head pulls through, and the rest, being overpowered by a sudden accession of load, give way successively, and a sufficient body of water escapes, the reaction and expansion of which produces the phenomenon known as an explosion. In this case, however, the *star corrosion* may be considered as an indication rather than a cause of the weakness, for appear-

ances indicate that the initial rupture was along the other margin of this piece, along the lap of the seam where a continuous groove had resulted from corrosion on the fire side of the plate, and having progressed faster, probably from unobserved leaks, gave way first. The sketch, Fig. 3, shows the construction of the parts on a larger scale. The leak that caused the corrosion of the fire side of the plate was probably only a sweating leak, which is the most dangerous because it is most likely to escape observation. If this had been a case of a dripping leak probably the surface below the seam would have suffered most, and perhaps have given way instead of that above the seam.

The effect of this blow-out was an opening of about half a square foot of area, through which the water was forced with terrific power, beginning at a theoretical velocity of about 100 feet per second and ending at something like half that, supposing that none of the free steam escaped from the steam room through the intervening water. Sixty cubic feet of water would thus escape in about two or three seconds, allowing for obstructions in the furnace, and everything movable would be driven before it, as was the case. The engineer, who was supposed to be in the fire room, made his way to the deck probably nearly dead, and was lost overboard. The fireman, his son, who was on the top of the boiler, in the act of shutting off the steam jet, was badly injured. The fire upon the starboard grates and coals in the fire room were blown against the woodwork abaft the engine and against the engine itself with a force sufficient to abrade the whitewash and paint with which these parts were ornamented. Government certificates and officers' licenses, that were duly posted according to law, were sadly defaced, but no serious damage was done to the boat, as would most likely have happened if the weak area had been of sufficient extent to have allowed of the instantaneous escape of the boiler contents.
