THE ACCIDENT TO THE STEAMER CITY OF PARIS.

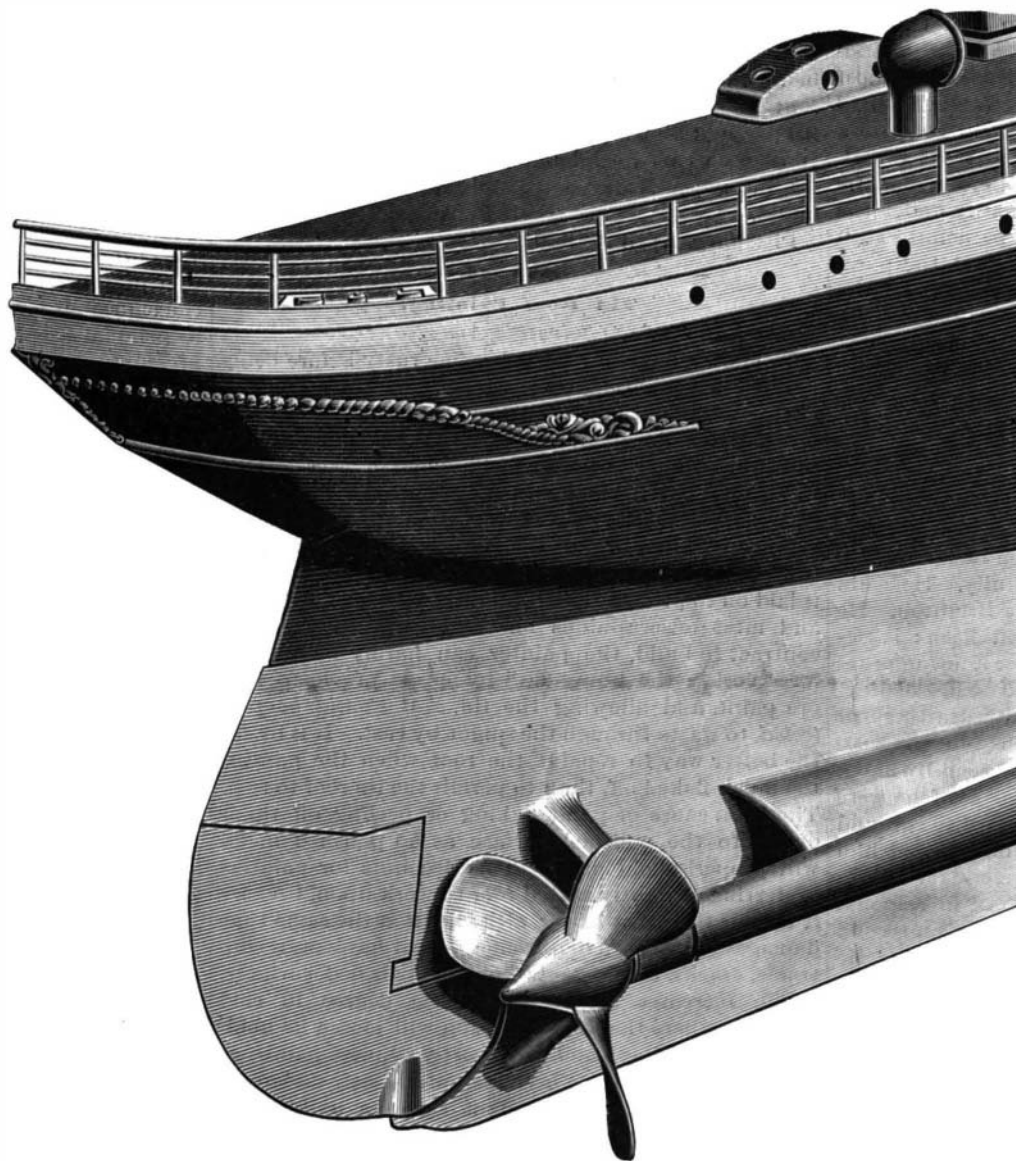
Each of the twin shafts passes through the ship's side through a stern tube in the usual manner. Immediately outside there is a flange coupling of the ordinary description, by which attachment is made to the outboard length of shafting. It was immediately on the forward part of this coupling, and therefore directly outside the stern tube, that the starboard shaft was broken square across. The position of this fracture is not shown in our engraving, it being somewhat forward of the part illustrated. The diameter of this part of the shafting is $20\frac{1}{4}$ in. The fracture was thick with rust on both faces, but there was every appearance of the metal being sound throughout and of excellent quality. On the whole, we should judge the shaft to be an excellent job, and the fracture to be entirely unconnected with any fault in the material. The outboard portion of the shaft abaft the coupling just referred to consists, we may say, of one length of hollow shafting 42 ft. long, and one length of solid shaft 15 ft. long, this latter length carrying the propeller. The total length of shafting abaft of the point of fracture was thus some 58 ft. or so.

This breakage of the shaft will of course fully account for the racing of the engine, while the subsequent damage done thereby can, we think, also be fully accounted for by causes we shall explain. Proceeding aft in our examination of the vessel, we found the two arms of the stern bracket intact, their attachment to the vessel being undisturbed. At their outer ends they are, or rather were, connected by a cylindrical boss which forms the support in which the propeller shaft revolves as shown. This boss, with the two arms and their palms by which they are attached to the hull, form one steel casting in the usual way. The thickness of metal in the cylindrical part is $3\frac{1}{2}$ in. This boss was fitted with the usual gun metal bush and lignum vitæ bearing strips. The cylindrical part of the casting was split clean across the top in a line with the axis. The reason of this was obvious; when the forward end of the broken shaft had commenced to fall, owing to losing the support of the casing, a twisting moment of considerable force was naturally exerted, and this the casting was unable to sustain. The length of the cylindrical part of the bracket is about 6 ft.

The top part of the bracket was split across when the twisting strain was brought upon it by the release of the forward end of the outside shafting when the casing was cast adrift in the dock. It should be stated that the fracture was quite bright and free from rust, showing that it had recently been made. It will be further evident that the cylindrical part of the casting could not be intact on its bottom side, or the shaft would not be released. There was, however, no occasion for any fracture to occur here throughout, and this brings us to the most interesting part of our report. The bottom part of the casting was worn through for nearly the whole of its length, and much reduced in thickness where not worn through. The metal liner, 1 in. thick, together with its end flanges, was also worn through, and was lying in the bottom of the dock. The brass sleeve of the propeller shaft had entirely disappeared, with the exception of two rings, presumably the collars at the end. The propeller shaft itself was practically undamaged, but the metal studs which attached the sleeve to the shaft were worn down

level with the shaft, and the shaft was slightly worn also.

This wearing away and consequent dropping of the end of the outer shafting we take to be the obvious primary cause of the whole mischief.

STERN AND SCREW OF THE S.S. CITY OF PARIS.
