BREAKAGE AND REPAIR AT SEA OF THE MAIN SHAFT OF THE STEAMSHIP UMBRIA.

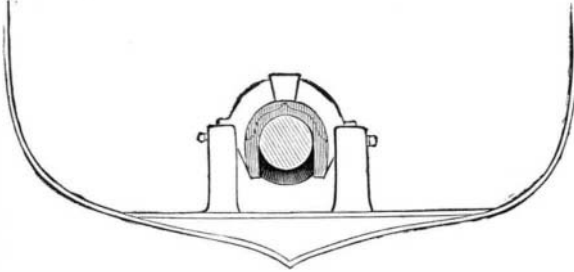
Fig. 1.—THRUST COLLARS OF THE SHAFT.

Upon the shaft of a screw steamer there is a section which is provided with a number of collars, larger in diameter than the shaft, that receive the longitudinal thrust of the propeller shaft. Fig. 1 shows the collared portion of the Umbria's shaft.

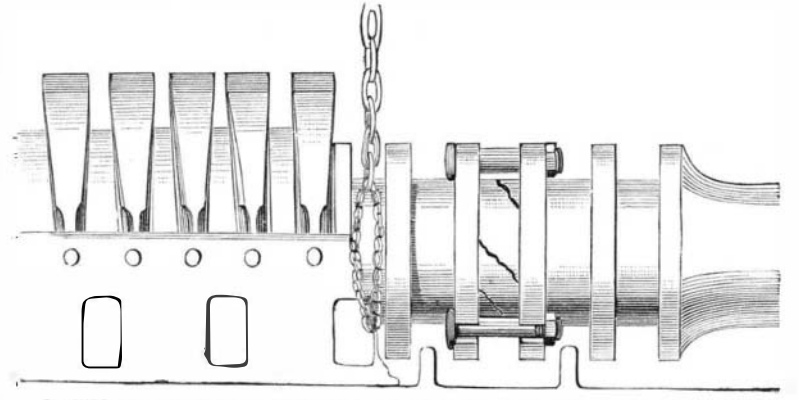
Fig. 4.—THE BROKEN SHAFT OF THE UMBRIA AS REPAIRED.

The fracture of the Umbria's shaft occurred in a very inconvenient place, namely, between two collars of the shaft, as indicated in Fig. 4. There were two distinct cracks in the shaft, the most serious one running dia-

gonally from flange to flange on one side of the shaft. The first thing done on discovering the injury was to support the shaft by passing a chain cable under the shaft, which chain was secured to the steel beams above it. To enable these beams to take the strain they were shored up with timbers. Next, three holes were drilled through the collars of the shaft on each

side of the break for the reception of large bolts. This was a work of great difficulty, owing to the limited space, and only five men could advantageously work at once. Shifts of five men each were employed, who worked night and day in six hour watches, operating with hand drills. The metal remaining outside the edge of the holes was chiseled away to permit the insertion of the coupling bolts, which were then dropped in and the nuts screwed up so as to strain the fractured edges of the shaft tightly together. In these operations it is estimated 180 inches of iron were drilled through. A clamp or strap was bolted around the shaft between the collar before the bolts were put in place. After the bolts were screwed up another strap was put around them, its flanges being turned inward. (See Fig. 5.)

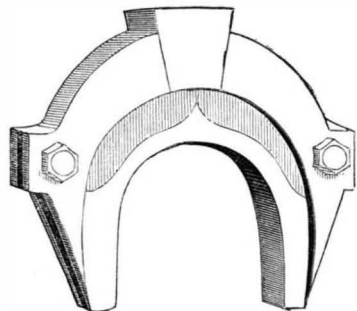
Fig. 2.—THRUST YOKE OR COLLAR BLOCK.

This portion of the shaft rotates between two longitudinal abutments of iron, called the thrust block. Into grooves in this thrust block U-shaped yokes or collars of iron are set from above (see Fig. 2), one of these yoke or collar blocks coming behind each of the collars of the shaft. The shaft collars exert their thrust against the yoke or collar blocks just described. (See Fig. 3.)

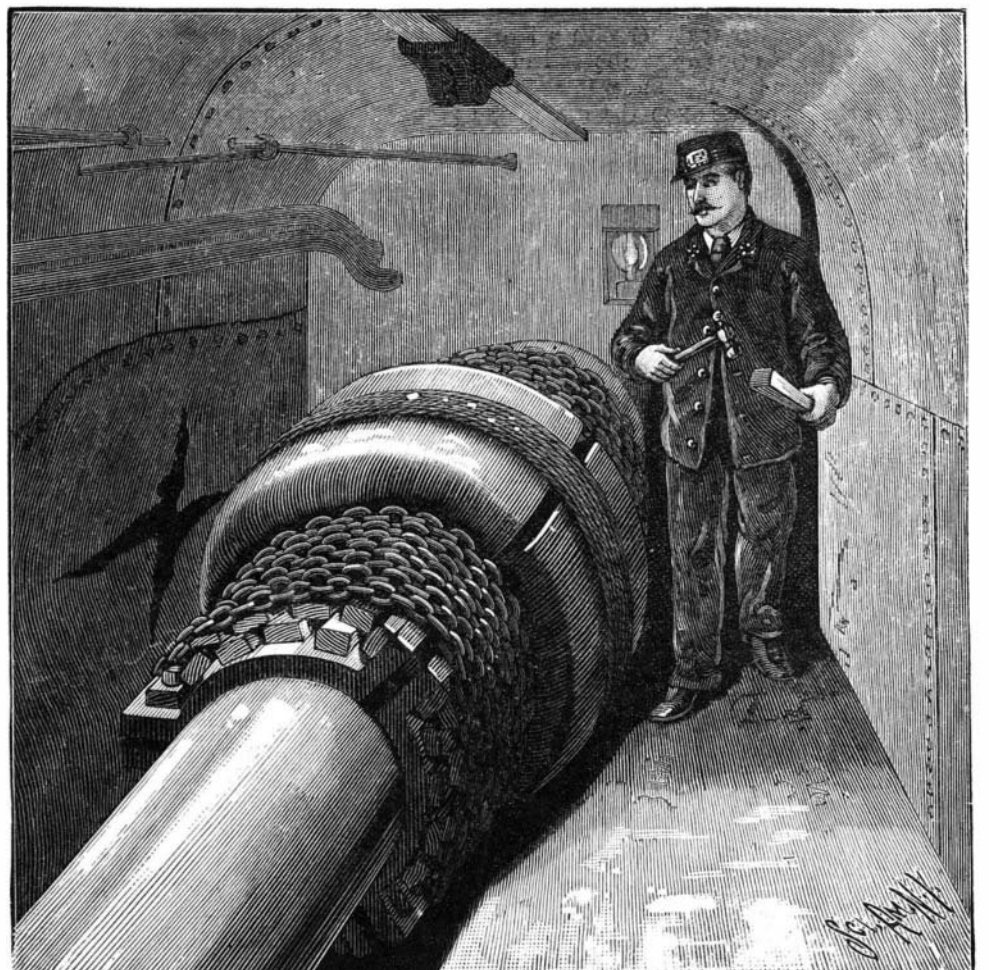
Fig. 9.—THE THOMPSON COUPLING AS APPLIED.

fully applied to the main shaft of the large steamer Veendam, which suddenly gave way at sea, in May, 1891. In this case it was necessary to re-enforce the Thompson coupling by means of chains and wedges.
