REPAIRING THE LEAK AT DRY DOCK NO. 3, BROOKLYN NAVY YARD.

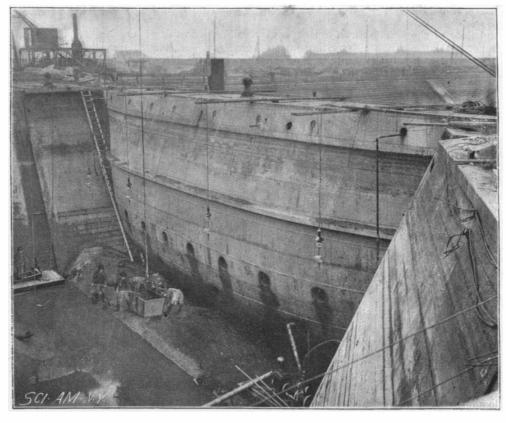
1.-REMOVING MUD FROM APRON IN FRONT OF CAISSON GATE.

The dock was emptied by the regular dock pumps, and, as the water fell, the cofferdam proved to be a remarkably tight job, practically no watercoming through. Our illustrations, Figs. 1 and 2, show the pumped out space between the dam and the caisson gate. The gate is resting on the inner sill, and the line of the outer sill can be traced by the drop in the level of the mud. About twenty feet beyond this is the edge of the apron, where the sheet piling was torn up by the dredge, as already explained. The water is seen standing in the holes which have been washed out around the vicinity of the leak. A day or two after our photographs were taken, the lowering of the water showed that the whole line of piling had been more or less battered up and torn away by the dredge bucket. It is little to be wondered at that the dock was leaking.

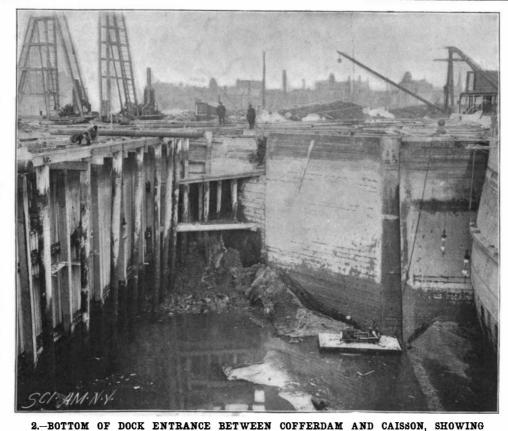
The new dock had not been many months in use before a serious leak developed, the water showing itself at the joints of the altar steps, near the caisson gate. It was at first supposed that water was making its way in by way of an old bulkhead which intersected the

LOCATION OF LEAK.

To make the dock thoroughly secure against further trouble, two lines of sheet piling will be driven. one in front of the damaged piling and another at the outer sill, on which the caisson gate is shown in the ac companying diagram. The new piles will be heavier -12 by 12 inch, in place of 8 by 12-and they will be 35 feet in length and driven as deep as they will go in the mud. The new piling will be driven up the slopes at the sides of the entrance, and carried out to a junction with the outside wall of piling which surrounds the entire dock. The present floor of the apron will be for supplying the 18,000 yards required by using the ripped up, the three or four feet of concrete which un-

great a depth as can be conveniently excavated. The flooring will then be relaid in two courses with broken joints, with its outer edge finished off in snug contact with the new line of piling.

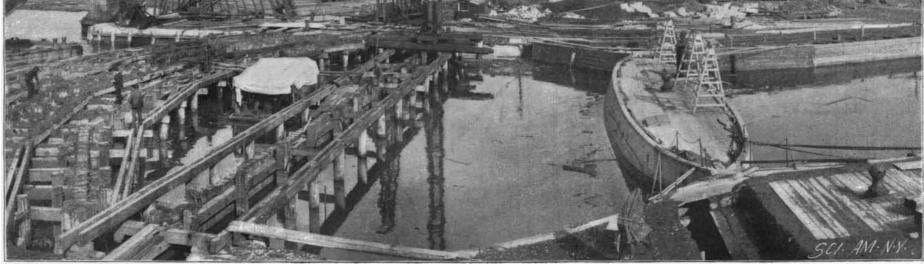
> In order to examine the break and make the needed repairs it was necessary to build a huge cofferdam across the entrance channel and pump out the water. The magnitude of the task may be judged from the fact that the channel is 156 feet wide and the depth of the water is 34 feet, measured from mean high water mark. This gives a total hydrostatic pressure of 2,885 tons, which had to be withstood by the cofferdam. The construction of the dam is clearly shown in the accompanying photographs, and in the sectional diagram, for which we are indebted to Naval Constructor Bowles, of the Brooklyn navy yard. The dam consists of a central wall of clay puddle contained within three lines of sheet piling, backed up by two embankments of gravelly clay, the toe of the inner embankment being held by a fourth wall of sheet piling as shown. By reference to the large engraving, Fig. 4, it will be seen that the cofferdam is curved, presenting a convex face toward the river, or, to speak more strictly, it is built with five plane faces, those on the river side corresponding to the chords of a circle of 125 feet radius. This is done to secure an arch effect and cause the

pressure of the water to be transferred to the walls of the channel, the latter acting as abutments. The lateral pressure thus set up is supposed to compress the lines of sheet piling and assist in keeping the joints watertight. Owing to the yielding nature of the sides of the channel, however, and the difficulty of driving the piles at the angles with a snug fit, it is a question whether a straight dam would not have been preferable. It would certainly have been cheaper, for it often took as long to fit and drive the angle piles as to drive the whole of one bent between them.

-COFFERDAM ACROSS ENTRANCE CHANNEL--DRY DOCK No. 3, BROOKLYN NAVY YARD.
