**THE OFFICIAL REPORT ON THE WRECKED SPANISH WARSHIPS.**

We have before us the full text of the official report of the naval board appointed by Admiral Sampson to investigate the condition of the wrecks of the Spanish fleet now lying on the Cuban coast. Accompanying the report are a series of photographs and a set of drawings showing the location of the shot holes on each vessel. In our issue of July 30 we gave several illustrations, reproduced from photographs taken the day after the fight, when the ships were still burning, which gave a vivid impression of the destruction wrought by our shell-fire and by the conflagrations which it started. It is not necessary to reproduce any of the photographs which accompany this report; but we present the four official diagrams showing the number, location, and size of the hits on each cruiser. They are of extreme interest, and those of our readers who are following closely the naval events of the war will find these diagrams of special value for future reference.

**DIAGRAMS SHOWING LOCATION AND SIZE OF HITS ON SPANISH CRUISERS.**

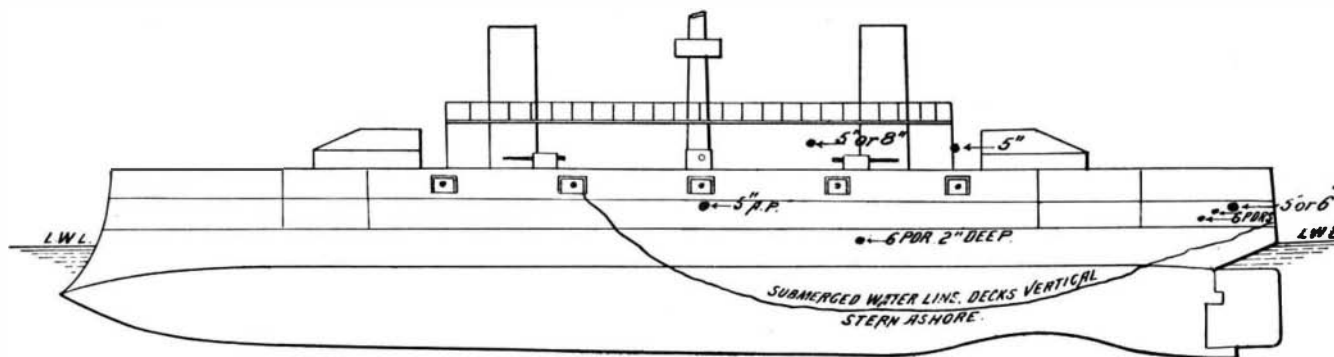
"CHRISTOBAL COLON."

The total number of hits that can be counted on the "Christobal Colon" is 8 or 9; but as only a small area of her sides is open to inspection, it is reasonable to suppose that she was hit more frequently than this. The most interesting hit was made by a 5-inch armor-piercing projectile, which struck the steel armor at the junction of No. 3 6-inch sponson at an angle of about 45 degrees, and after penetrating nearly through, rebounded. The hits on this vessel were chiefly received during the long chase by the "Brooklyn" and the "Oregon."

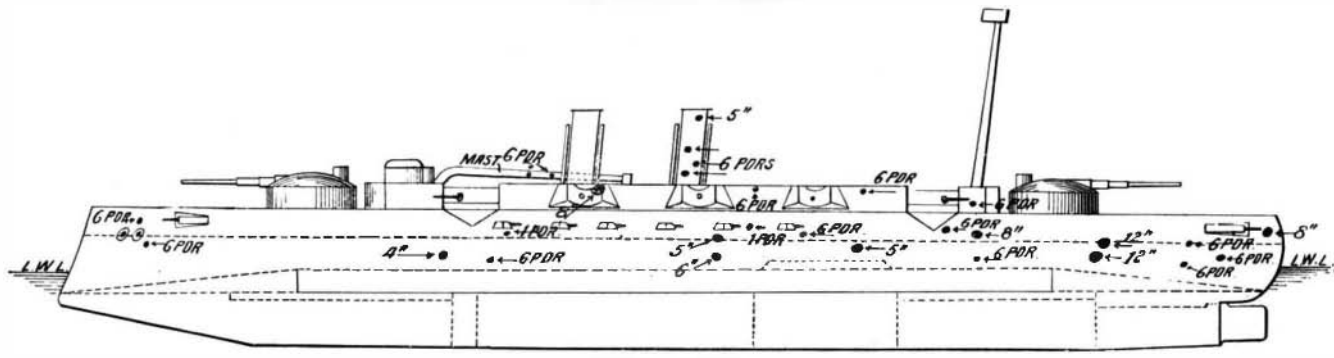
"MARIA TERESA."

**Effect of Gun-Fire.**—The "Maria Teresa" was struck twenty-nine times, as was also the "Vizcaya." More than half of the hits were by 6-pounder shells, though it was the larger shells that wrought the greatest destruction. An 8-inch shell struck the shield of the second 5½-inch gun, passed through it, ranging aft, and exploded. "The effect of the explosion," the report says, "upon almost everything about the decks in that vicinity must have been terrific." Another interesting hit, showing the effect of bursting shell in the coal bunkers, was made by a 5-inch gun, just abaft the after smoke-stack, under the berth deck. It passed through the wing passage and exploded in a coal bunker, rip-

port side away from the frames, completely wrecking everything in that compartment, and made a large ragged hole about four feet square on the starboard side. They both entered at an angle of about 45 degrees with the normal, ranging from aft forward.

"An 8-inch shell struck the gun deck just under the after barbette; passed through the skin of the ship and exploded, ranging aft. The damage done by this shell was very great. All the men in that locality must have been killed or badly wounded. The beams were torn and ripped, and the longitudinal bulkhead between the two cabins was badly damaged. The fragments of this shell passed across the deck and out through the starboard side at an angle of 45 degrees. This shell also cut the fire main."

The only hits made by the largest shells landed on this vessel. It will be seen from the diagrams that no 12-inch and only two 12-inch shot-holes were found on the wrecks. The two 12-inch shells entered just under the berth deck. They entered through almost the same hole. They exploded in the stern torpedo manipulating room, cutting the beams of the berth deck on the

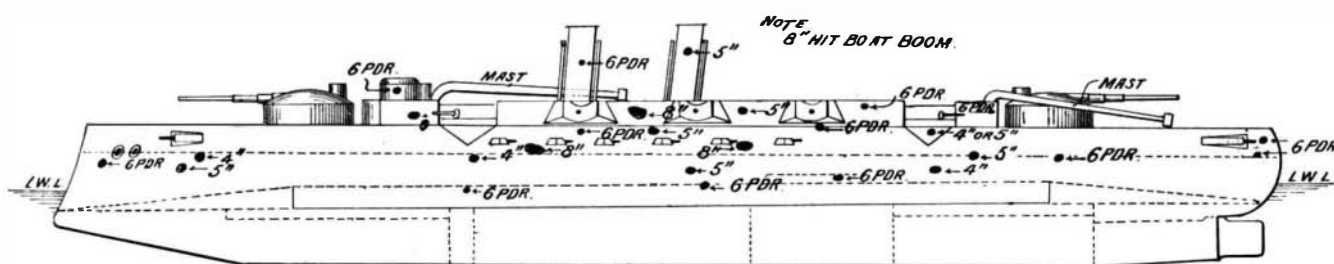
"VIZCAYA."

**Effect of Gun-Fire.**—The "Vizcaya" received a larger proportion of large rapid-fire and 8-inch shells than any other vessel, being struck by no less than 16 of these shells as compared with only 13 hits by the 6-pounders. The effects on the crew were proportionately disastrous, and the report states that "it is evident that the fire of the gun crews of the 'Vizcaya' was very materially lessened and almost silenced by their not being able to serve their guns under the severe fire poured upon them by our ships."

The number of shell that struck the ship seemed to show by their direction that about one-half struck as she was leaving the harbor—the shell ranging aft; and the other half as she was attempting to run away.

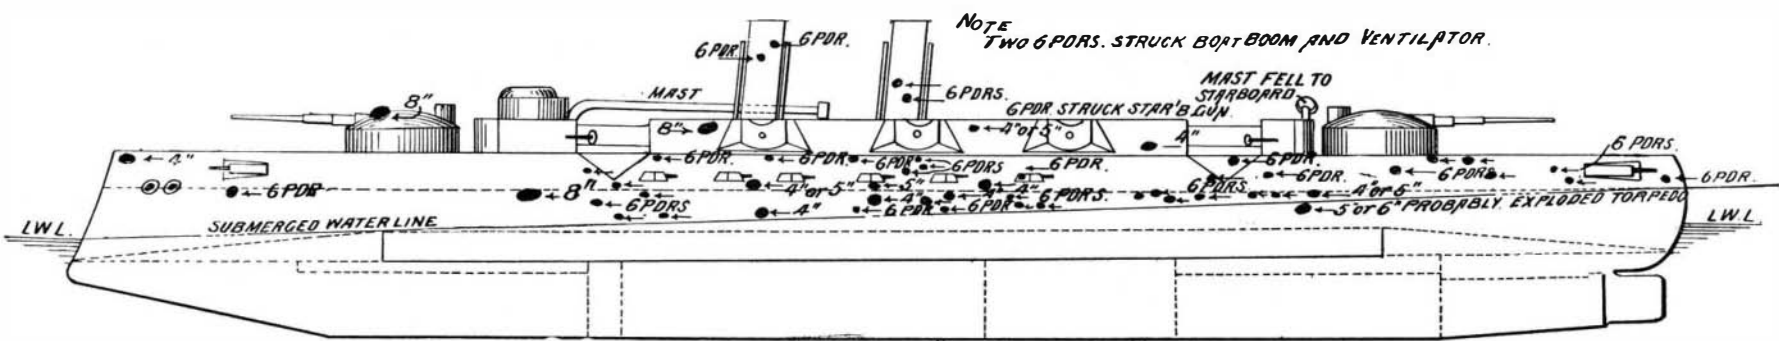
"OQUENDO."

"ALMIRANTE OQUENDO."  
This vessel suffered more severely than any other vessel. She was hit 57 times, or twice as frequently as the "Teresa" and "Vizcaya," 43 of the hits being made by 6-pounder guns. The wreck lies uneasily, considerably down by the stern, with a slight heel to starboard. The destruction worked by our gun-fire was completed by fire and magazine explosions. The engines and boilers, however, appear to be intact, the protective deck amidships having apparently done its work well in this ship, and indeed in the case of all four cruisers; but the explosion of the magazines and torpedoes have wrecked the "Oquendo" beyond all hope of saving the ship. The hull is practically broken in two at the forward turret. An interesting structural fact is brought out at this point; namely, that there is a decided weakness at the junction of the forward and midship portions of the vessel, arising from the discontinuity of the protective deck.

The 8-inch shells demonstrated their destructive power on this ship, one of them striking the hood of the forward 11-inch gun, at the edge of the port, bursting, and evidently killing every one in the turret and disabling the gun. This is a case where the danger of

As evidence that some of our gunners must have got the range and direction with great accuracy, we direct attention to the concentration of shot-holes below the forward 5½-inch gun sponson, where there are seven holes made by a 6-pounder besides one 8-inch hole. Another concentration of fire is seen on the berth and gun decks below the sponson of the after 5½-inch gun, where there are nine hits by 6-pounders. In calculating the effects of these little shells, it must be remembered that they all passed through the unarmored shell of the ship and burst into flying fragments, one 6-pounder being easily capable of killing or disabling a whole gun crew.

It will be seen from the diagram that a considerable portion of the hull above the flotation line was submerged when the examination was made, so that it is probable that a dozen or more hits lay below the water and could not be observed.
