**AMERICAN ARMOR PLATE FOR A RUSSIAN BATTLESHIP.**

By the courtesy of the Carnegie Company we are enabled to present the accompanying illustrations of certain armor plates which were recently tested by the naval authorities at the Indian Head proving grounds. The plates were manufactured under two different processes and were subjected to two different kinds of tests. The two plates which show the long, horizontal scoring form part of a large number which were manufactured for the flat portions of the protective deck of the new Russian battleship "Retvizan," which is now under construction for the Russian government at the Cramp Shipyard, Philadelphia. The third plate showing the mark of five separate impacts represents the side plating for protecting the rapid-fire battery of the same vessel.

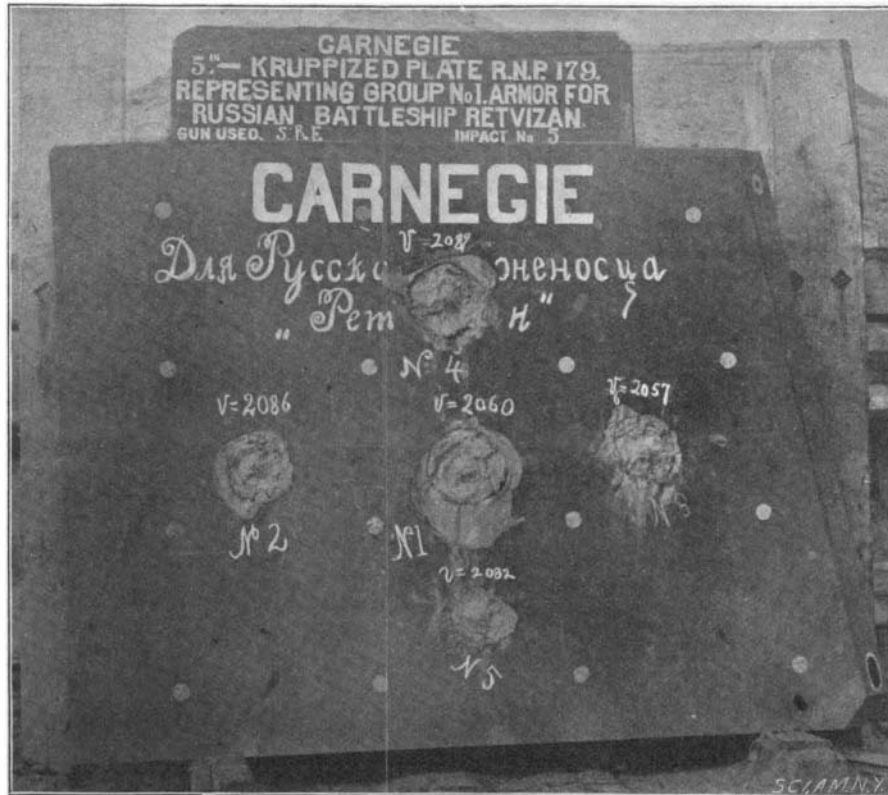
Fig. 1 is one of the most remarkable photographs of armor-plate test ever taken. The plate was manufactured under the Krupp patents by a process which is a development of the American Harveyized process, and has shown results which are a great advance in respect of hardness of face, depth of hardening and the general toughness of the body of the plate.

only did the plate resist penetration and break up the projectiles, but it had sufficient toughness to hold together without cracking or fracture. The result is positively astonishing to anyone who has not kept close touch of the progress which is being made in armor plate manufacture under the Krupp process. In spite of the enormous increase of late years in the power of naval guns, the victory in the struggle between the gun and the plate rests to-day with the latter. We commend this photograph to the thoughtful and intelligent attention of the two or three Congressmen who have been endeavoring only too successfully to prevent the country from using Krupp armor upon its ships. Had this plate been of the kind which they are anxious to force upon the navy, it would probably, under such a fierce attack as the above, have been cracked from end to end. We would also draw their attention to the fact that this plate was made in America to be placed upon the sides of a ship which is being built in this country for the Russian navy, and we would ask whether it is desirable that we should place the best armor upon foreign ships and clothe our own with armor of a distinctly inferior grade.

**Fig. 1.—TEST OF 5-INCH KRUPP PLATE FOR RUSSIAN BATTLESHIP "RETVIZAN."**  
Impact No. 5 by 5-inch, 50-pound projectile; striking velocity, 2,082 feet per second; striking energy, 1,502 tons. Projectile smashed, point welded to plate, penetration 2 inches. Penetration on similar Harveyized plate would have been 4.4 inches.

The first shot fired from a 5-inch rapid-fire gun struck in the center of the plate with a velocity of 2,060 feet a second and broke up, the penetration being only 2 inches, and the point of the shell remained embedded. The velocity of the second shot was 2,086 feet per second, of the third 2,057 feet per second, and of the fourth 2,089 feet per second, and the last shot struck with a velocity of 2,060 feet per second. In every case the projectile failed to penetrate more than about 2 inches, and left its point welded into the face of the plate. Had the ordinary Harveyized armor been used the penetration would have been more than twice as much, or about 4.4 inches. It will be noticed that not

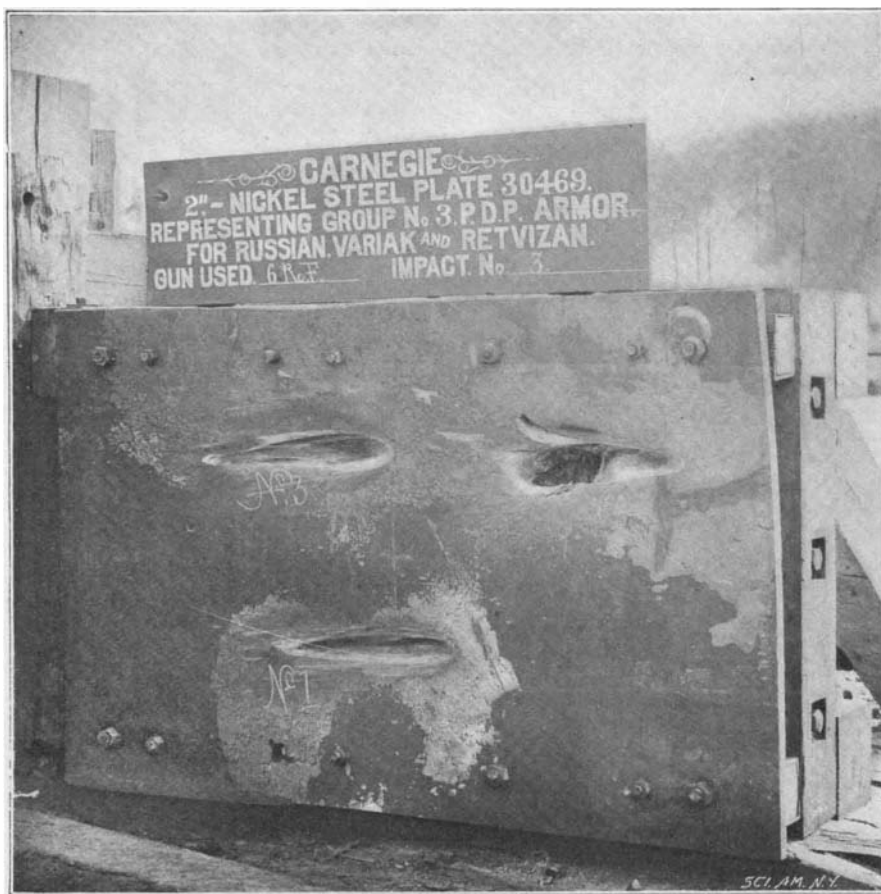
**Fig. 2.—TEST OF 2-INCH NICKEL-STEEL PLATE.**

Attacked by 6-inch projectiles fired at an angle of 15 degrees with the plate. Impact No. 3, by 6-inch projectile; striking velocity, 1,639 feet per second.

test by firing a number of 6-inch armor-piercing projectiles at angles of about 15 degrees to the plates. The plate shown in Fig. 2 was 2 inches thick. It will be seen that two of the shots made long indentations and bulged the plate considerably, and only one got through. The plate shown in Fig. 3 was made up of two 1-inch plates, and the projectiles were 6-inch armor-piercing Carpenter projectiles, the striking velocity in the case of the lower impact being 1,160 feet per second. The first shot deeply scored the outer plate, but the plate was not broken. In the case of the second shot, the outer plate was cut through for a length of 26 inches, the opening being 1 1/4 inches wide

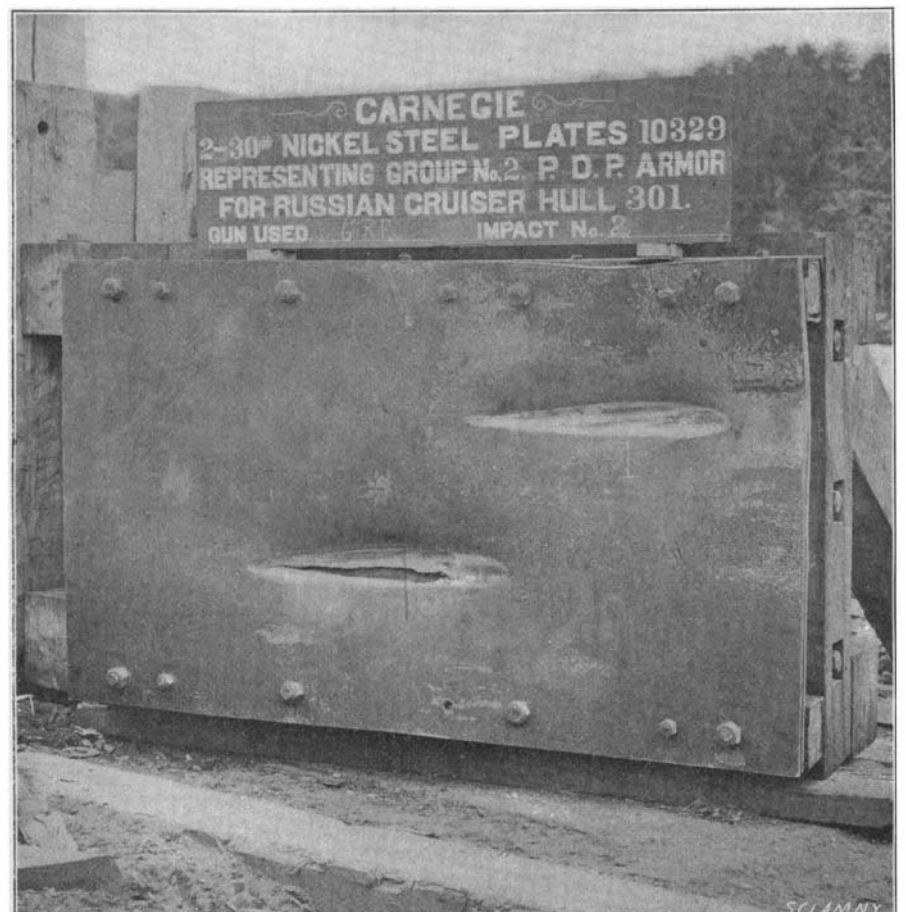
at the middle of the fracture, but the second or backing plate was not cut or even scarred. These plates are of ordinary soft nickel steel treated by the Carnegie system and the results, considering the energy of the projectile and the angle of impact, are very satisfactory.

**Fig. 3.—TEST OF TWO 1-INCH PLATES.**

The lower impact made by 6-inch projectile; striking velocity, 1,160 feet per second; cut through outer plate but failed to injure second plate.
