THE STRATFORD TROLLEY CAR DISASTER.

The accident occurred on the afternoon of Sunday, August 6, on the extension of the Bridgeport and Stratford Electric Railway through the north part of Stratford to Shelton, ten miles north, and known as the Shelton Street Railway. The extension runs north from the old road along the highway of the former town for about a mile, and then turns to the left over private property across the site of an old mill-pond, which had been drained during the building of the road. The track crosses the depression in which the pond lies by means of the steel bridge shown in the accompanying illustrations, which was built by the Berlin Iron Bridge Company, and, except in the particulars to which reference is made later in this article, appears to be of the best design and construction. From the point where the track leaves the highway to the bridge is about 700 feet, and the grade descends at the rate of three feet in one hundred until the bridge abutment is reached.

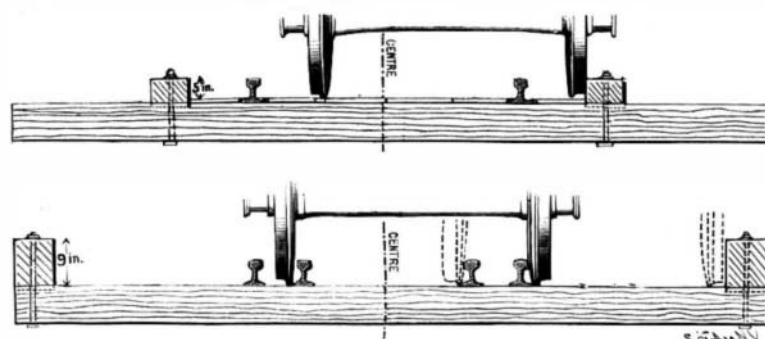
The total length of the bridge is about 400 feet. It is carried on steel piers resting upon masonry foundations. The trusses are of the deck type, and the floor consisted of ties 6×8 inches \times 14 feet in length, laid on and bolted to the steel trusses and spaced and held in place by two guard-rails of oak measuring 6×10 inches, which were notched down over the ties and secured to them by screw bolts. The guard-rails were spaced about 12 inches on the outside of the rails.

1.—The upper drawing shows bridge floor as built; the lower drawing shows improved floor with both inside and outside guard-rails.

The second lesson is that the style of guard-rail used on this bridge is unable to keep a car on the bridge if it jumps the rails when going at high speed. If wooden ties are used they should be inside and not outside the rails, for we must remember that the tread of the wheel is raised about an inch from the ties by an amount equal to the height of the flange, and if, as in this case, planking is laid on the ties, another inch of height is lost. It is probable that the effective height of the guard-rail was not over 3 inches, for we must subtract one inch for notching down over the ties, one inch for the planking, and one inch for the height of the wheel flange, leaving only 3 of the 6 inches of depth of the guard-rail available.

As a matter of fact, however, good construction demands that a steel rail guard be placed about 5 or 6 inches inside of each main rail. Had such rails been in place on this bridge, when the right-hand wheel dropped over to the right of its rail the left-hand wheel would have had the full height of a 5-inch steel rail to prevent its further movement in a lateral direction across the bridge. If by any chance it had climbed this rail, it would still have had to climb the right-hand steel guard-rail, and with the assistance of an 8 by 10 wooden guard-rail placed on the extreme ends of the ties, as shown in our engraving, the further progress of the car would be arrested.

A floor system constructed on the lines above shown would, in our opinion, be a perfect safeguard against such disasters as that of August 6; but as long as the control of a derailed car is left to a couple of wooden stringers placed on the outside of the rails, the chances of its remaining on the bridge are exceedingly slim.

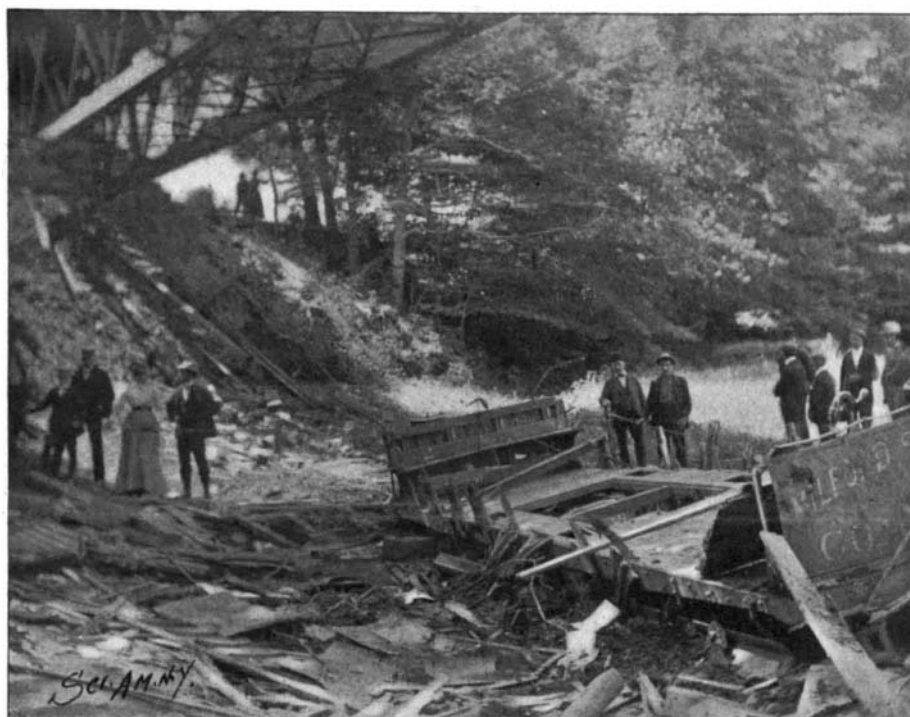
rail and the guard-rail. The wheel then ran for 28 feet against the inside of the guard-rail, which it finally mounted, the car continuing to run diagonally upon the ties for another 30 feet until it finally toppled over and fell bottom up a distance of 37 feet to the bed of the mill-pond below. The fearful mortality was largely due to the weight of the heavy motors under the floor with the added weight of the wheels crushing the roof-support-

2.—Wrecked car lying beneath the bridge.

ing posts, the victims being thereby imprisoned between the floor of the car and its roof. Our upper illustration shows the car floor intact except the motor opening, while the seats are demolished excepting that in the rear. The car was turned back into the position shown and the dead removed from the spot indicated by the confused mass of debris.

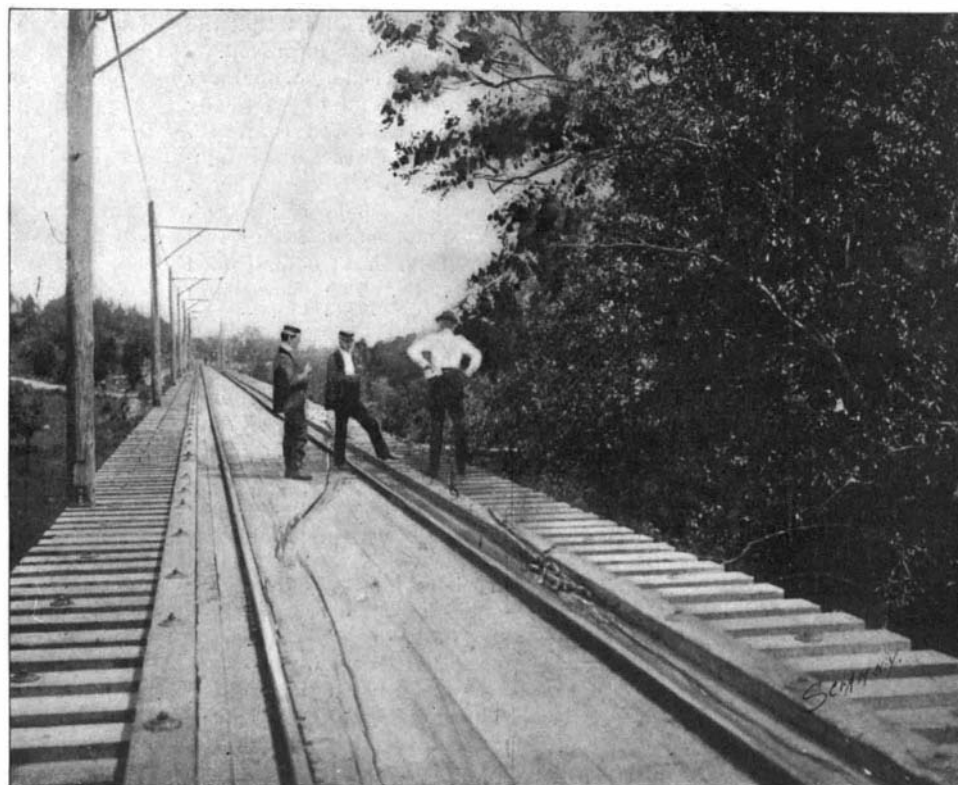
3.—Deck view, showing where car left the bridge.
STRATFORD TROLLEY CAR DISASTER.

The tracks of the derailed car are outlined in our lower illustration, which was made from a photograph kindly loaned us by The New York Herald. It will be seen by the track on the right that the face of the right wheel pressed against the edge of the guard-rail with such force that it finally struck a soft or biting spot, which assisted it in mounting the guard-rail.
