RECONSTRUCTION IN CONCRETE OF DRY DOCK No. 2, NEW YORK NAVY YARD.

NEW CONCRETE DOCK, BROOKLYN NAVY YARD.

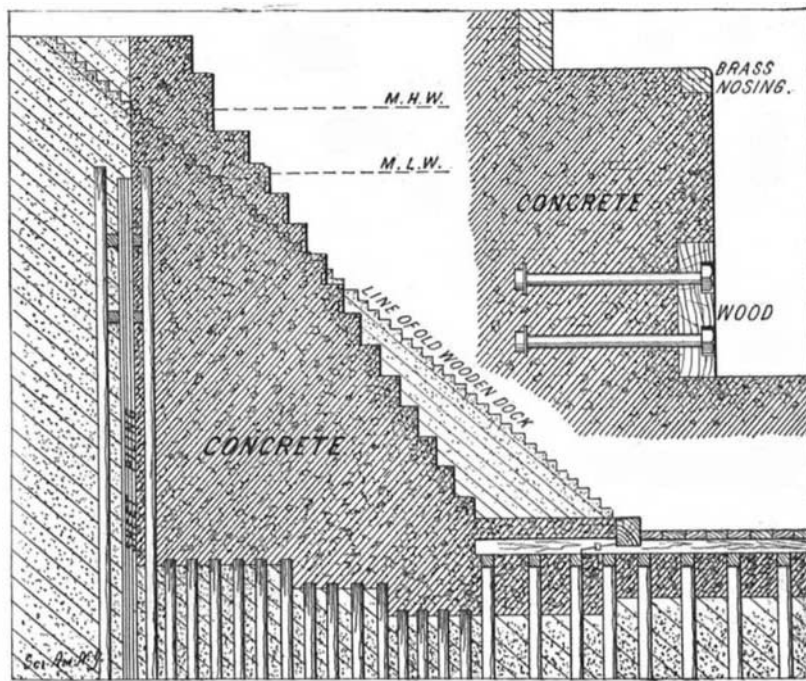
It will be noticed that the slope of the side walls of the concrete dock is considerably steeper than that of the old structure, the two being in the ratio respectively of 2 to 3 and about 1 to 1. The result is that the new dock has a form which is very much better adapted to the docking of ships, inasmuch as it gives more room (22 feet on the floor) where it is greatly needed, and brings the upper edges of the dock closer to the sides of the ship—advantages which greatly facilitate the handling of material and the general

Cross-Section Through Side Wall of Old and New Dock, and Detail of Altar Protection.

In carrying out the repairs, the steps, or "altars," as they are called, were first stripped to the level of the lower guide-wales of the sheet-piling, as shown in the lower engraving of our first page, and the backing was excavated to the same level. The wall of sheet-piling was then driven, the piles penetrating to a depth of 54 feet from the ground level. The stripping off of the timber structure and the excavation of the backing was then carried down until it was possible to put in position the shoring timbers, which will be noticed extending from the longitudinal wales to the old sill or bottom altar at the floor of the dock. The excavation was then carried down to the floor level and round piles were driven over the whole surface, the distance from center to center of the piling being 2 feet. The piles were then cut off about 6 inches above the ground, as shown in the accompanying transverse section of the dock. On this foundation, as thus formed, was built up the concrete monolith, its outer face abutting against the wall of the sheet-piling and its inner face being stepped into altars. It was originally intended to build the altars of granite; but to avoid the delay that would be caused by waiting for the delivery of the granite, it was decided to build them of concrete. To protect the altars, 1½ by 2¼-inch brass nosing-strips were laid along their edges, and 3 by 12-inch pine fender-strips were let into the risers, as shown in the accompanying drawing.

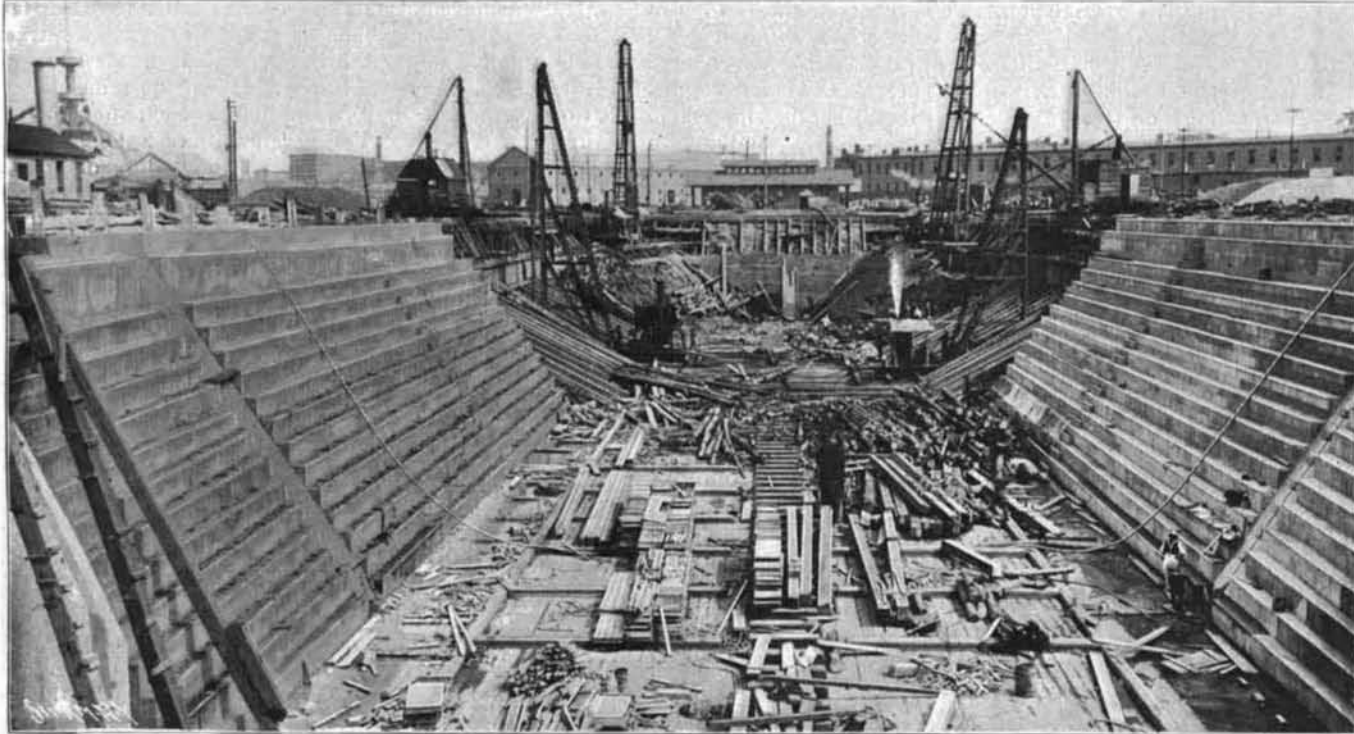
Width of floor of old dock, 50 feet; of new dock, 74 feet.
View Showing One-half of Dock Reconstructed in Concrete.

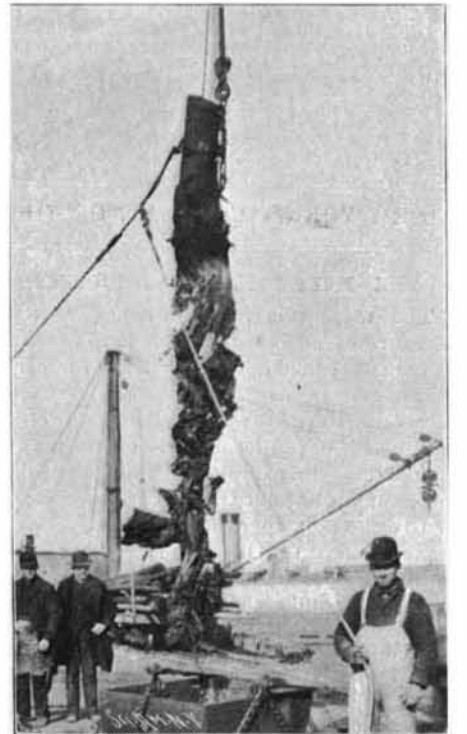
Result of striking an obstruction.
A Pile from the Old Dock

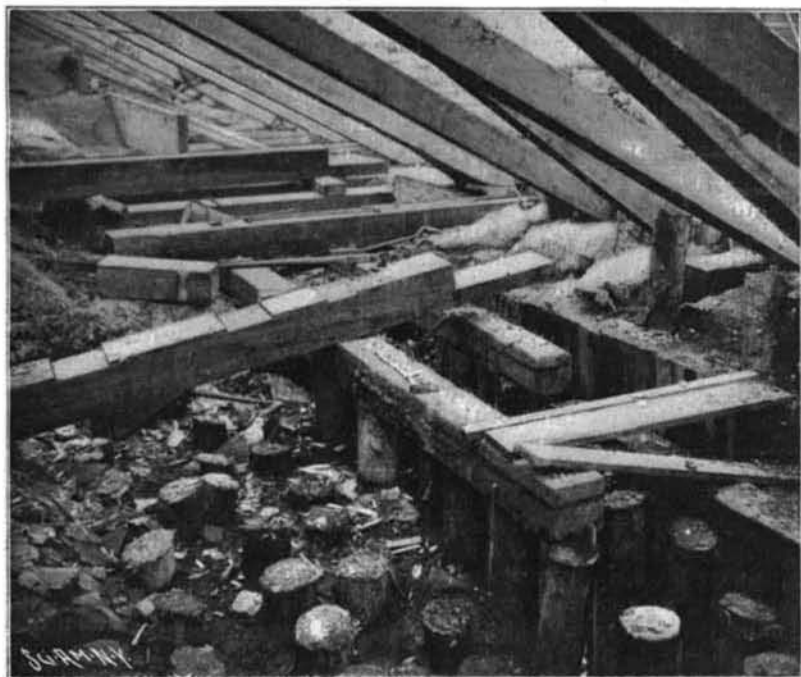
Pile Foundation for Concrete Monolith.

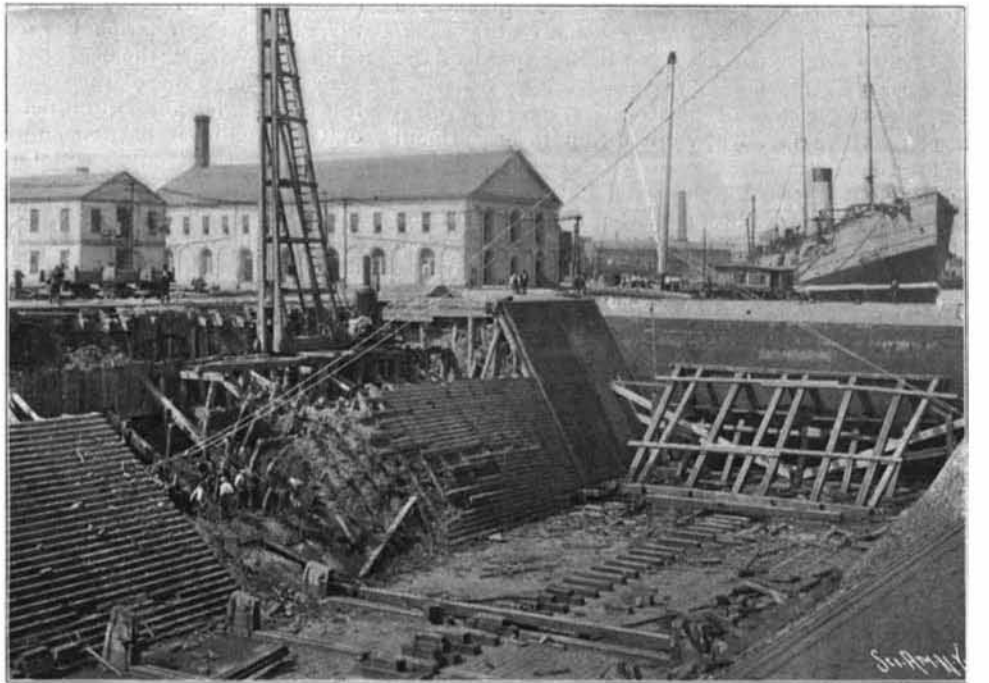
In the case of the dock now under consideration, it seems that during a heavy and prolonged rain storm last year, the culverts proving insufficient to carry off the storm water, it flowed over the surface of the navy yard and collected behind the walls of the dock, which proved unequal to the strain upon them, and bulged out at the point shown in one of our first page illustrations, to the extent of several feet, breaking off the 12 x 12 caps, and generally wrecking the structure over a considerable portion of its area. It was decided that the most satisfactory way to repair the damage would be to reconstruct the walls of the dock in concrete.

Spot at which Side of Dock was Burst In.

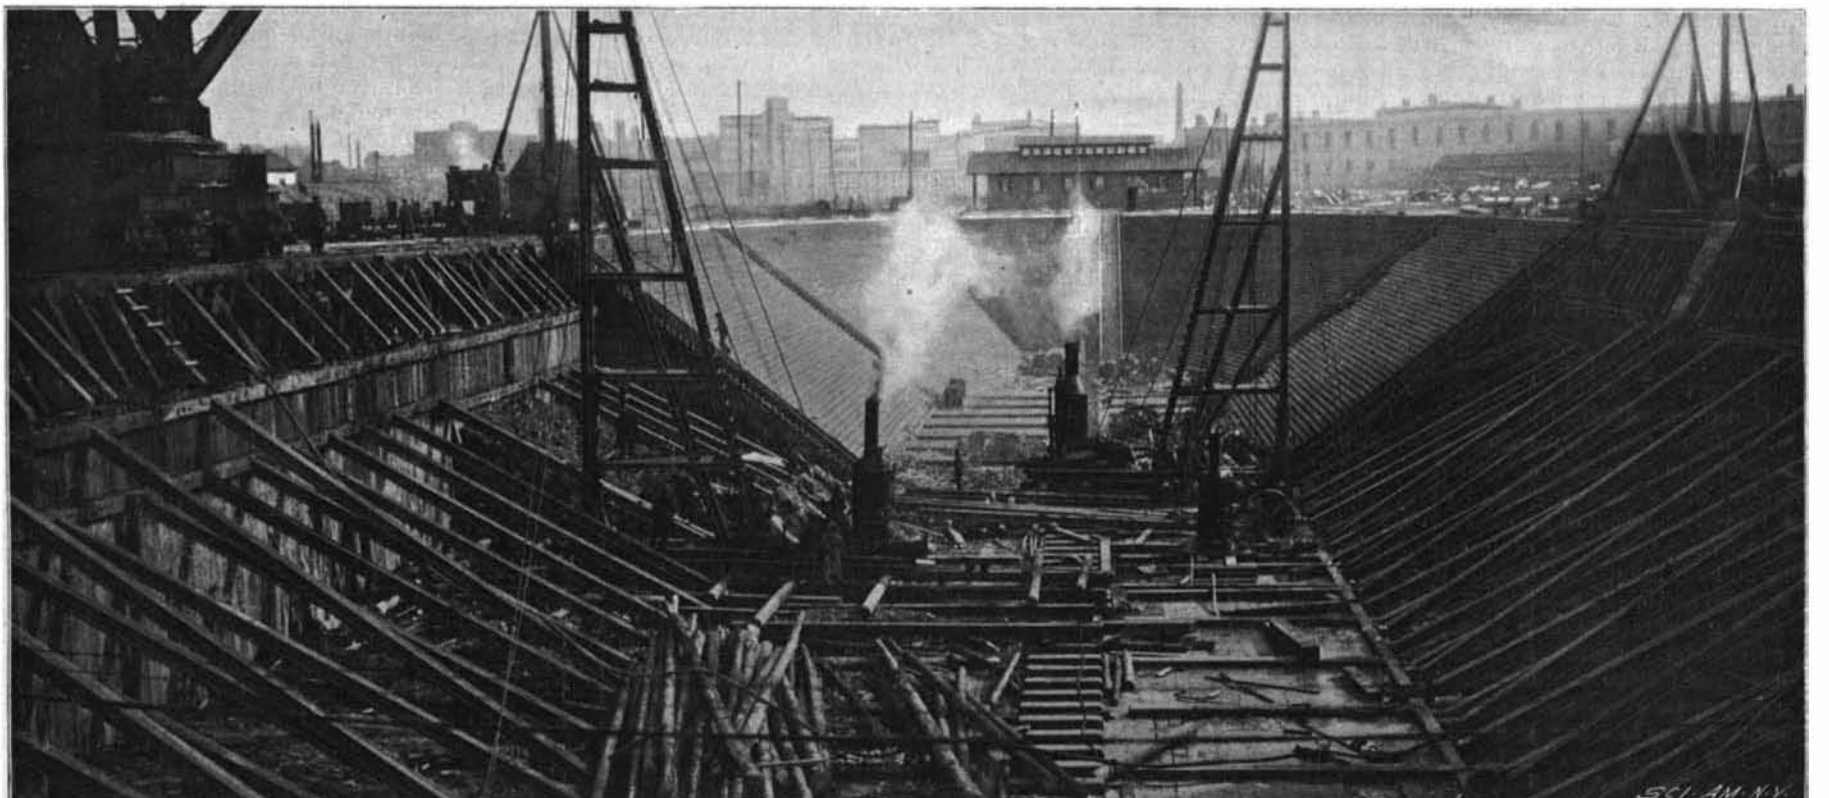
View Showing Portion of Old Wooden Dock and the Excavation for New Concrete Structure.
FROM WOOD TO CONCRETE—REPAIRS TO DRY DOCK No. 2, BROOKLYN NAVY YARD.—[See page 246.]
