**SOME VIEWS AND LESSONS OF THE SAN FRANCISCO DISASTER.**

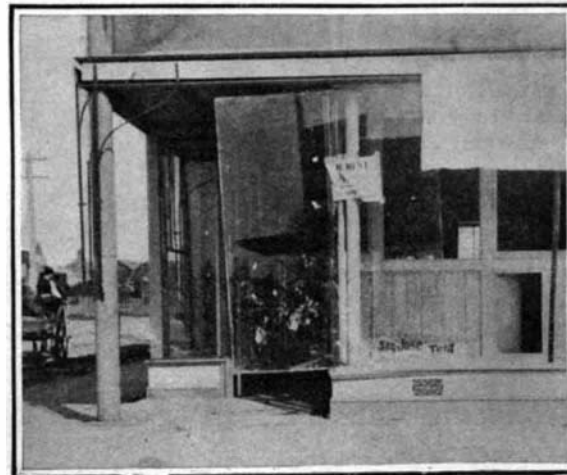
**A Window Plate Glass Shifted in Its Frame Unbroken.**

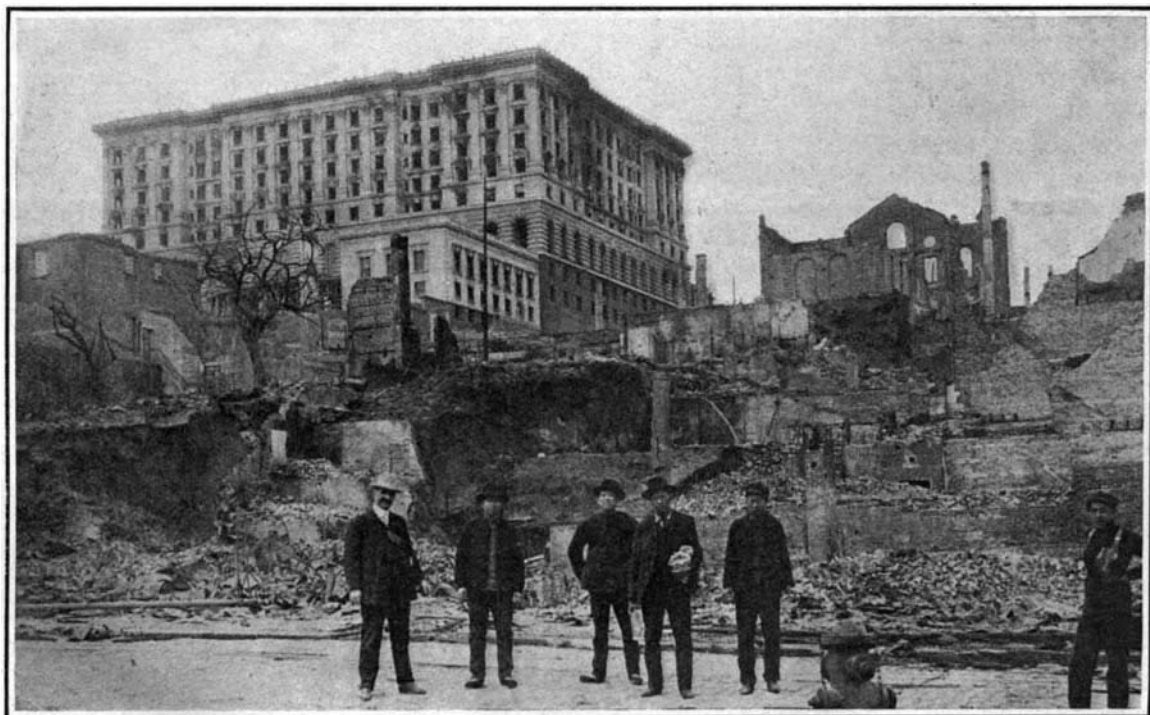
**New Fairmount Hotel of Modern Construction Still Standing Amid the Ruins of Older Inflammable Buildings.**

Very impressive is the view showing the great Fairmount Hotel, looking down like a modern Parthenon upon the crumbling ruins which strewn the slopes of

the hill on which it is built. The earthquake had but little effect upon this costly structure, and what damage it sustained was due to its having been completely swept by the fire. Two of our engravings, those of the Hibernia Savings Society Building and the post

The "Fairmount," of steel and terra-cotta, unfinished, is comparatively little injured, and with interior renovated can soon be occupied.

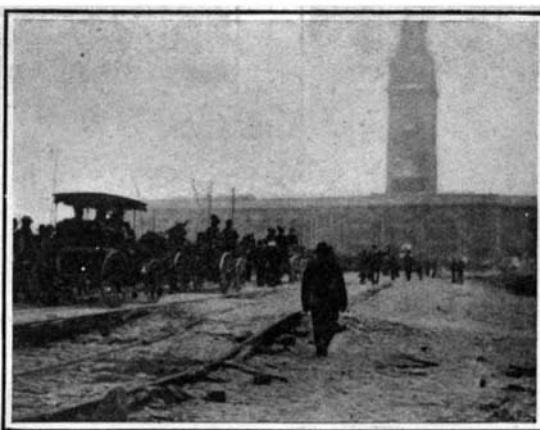
**Crevice and Subsidence of Car Track.**

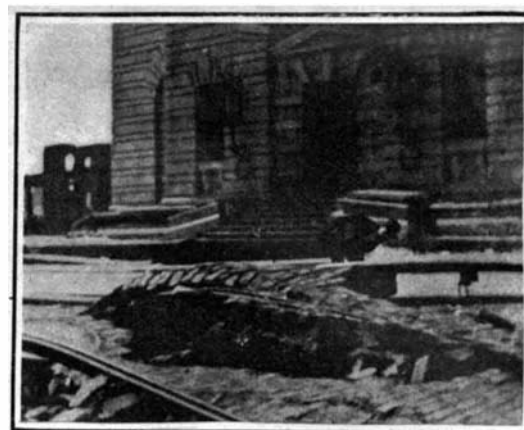
**An Upheaval of Street Car Tracks.**

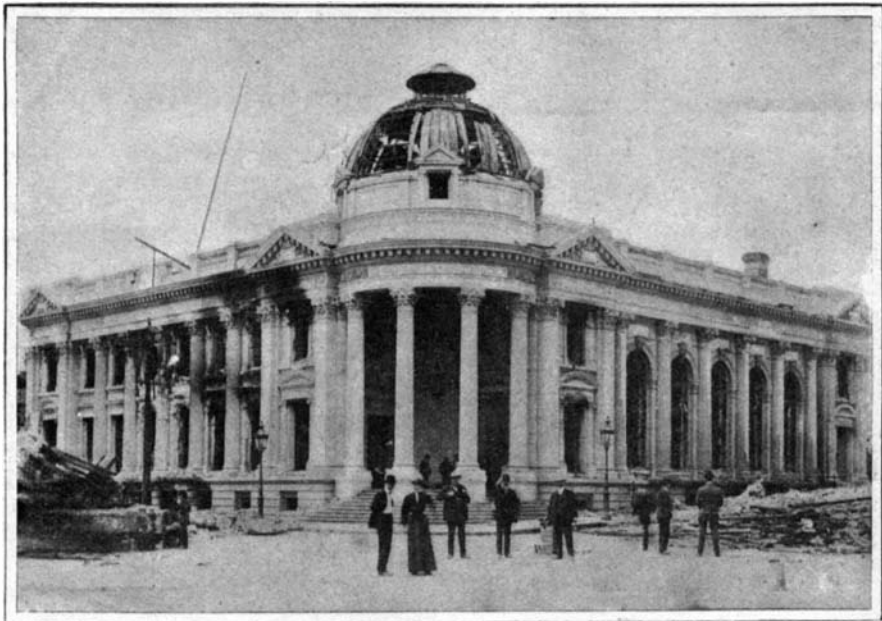
office, seem to prove further that a structure which is massively built of cut stone or first-class masonry, if it be of moderate height, can also endure extremely rough usage without any material injury. The damage to the Hibernia Savings Society Building by the earthquake seems to have been slight, and its wrecked appearance is due to its being completely burnt out.

**Hibernia Bank. Damage to This Building was Mainly by Fire.**

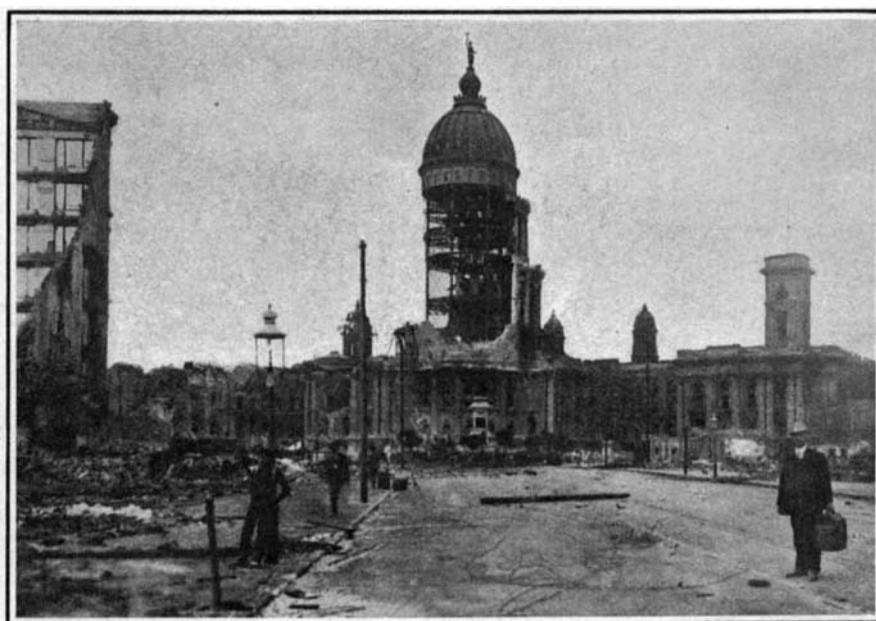
on this question is the one showing the ruins of the tower and dome of the new City Hall. It will be noticed that the internal steel structure and the metal dome of the tower, even to the figure that crowns its summit, are standing intact, while the two-story circular colonnades, massive though they were, have been almost entirely thrown down. It is probable that the architects trusted to the great thickness and mass of the masonry to give it independent stability, and that it was not very strongly tied into the steel framework. Had the masonry and steel been thoroughly bonded together, we think it is probable that

the tower would have been left standing practically intact to-day.

**Effect of Earthquake on the City Hall, Showing Steel Frame and Dome Intact; But Masonry Thrown Down.**

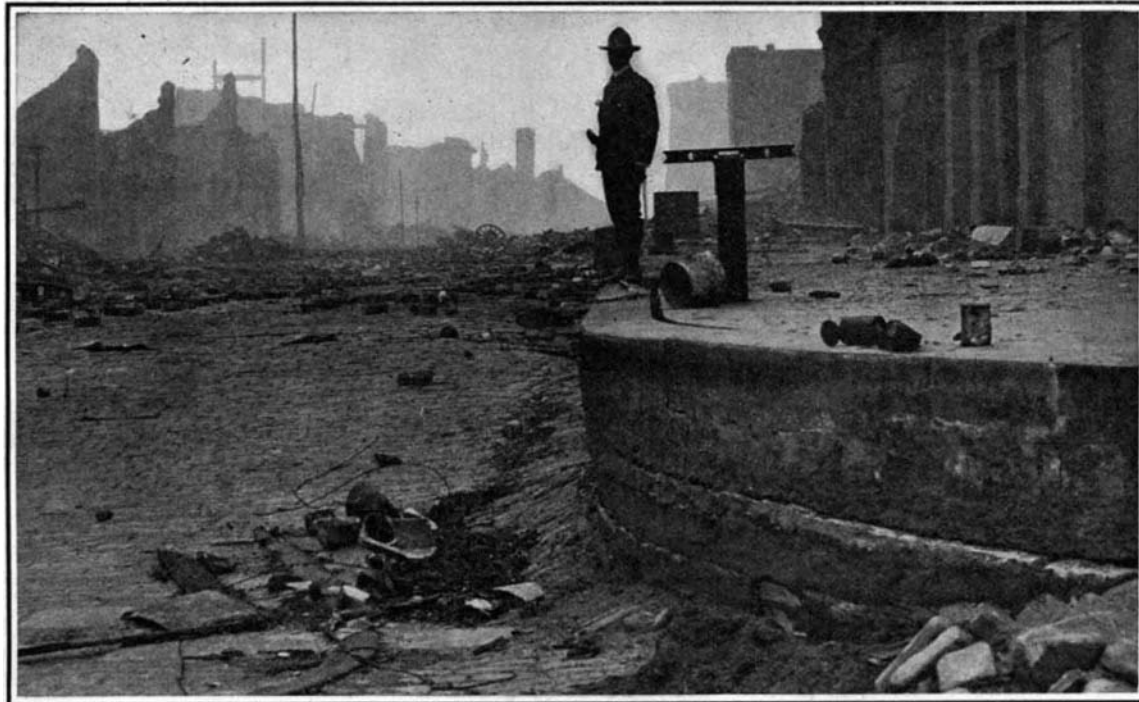
holds it be shaken with rapid oscillations. When the shaking is over the fluid will resume its normal level; but the loose overlying alluvial material above the underlying rock, not having the fluidity or ease of the readjustment of the water, will permanently retain many of the hollows and billows produced during agitation. An excellent illustration of this action is shown in the sidewalk surrounding the post office, and in the upheaved and depressed tracks pictured in two of our smaller cuts. So also a view taken in Market Street shows that the whole mass of filled-in material of the street has been shaken down some five feet, just as grain or other loose material may be shaken down in a sack or other receptacle.

Freak of Earthquake. Market Street Sinks Five Feet Below Curb.

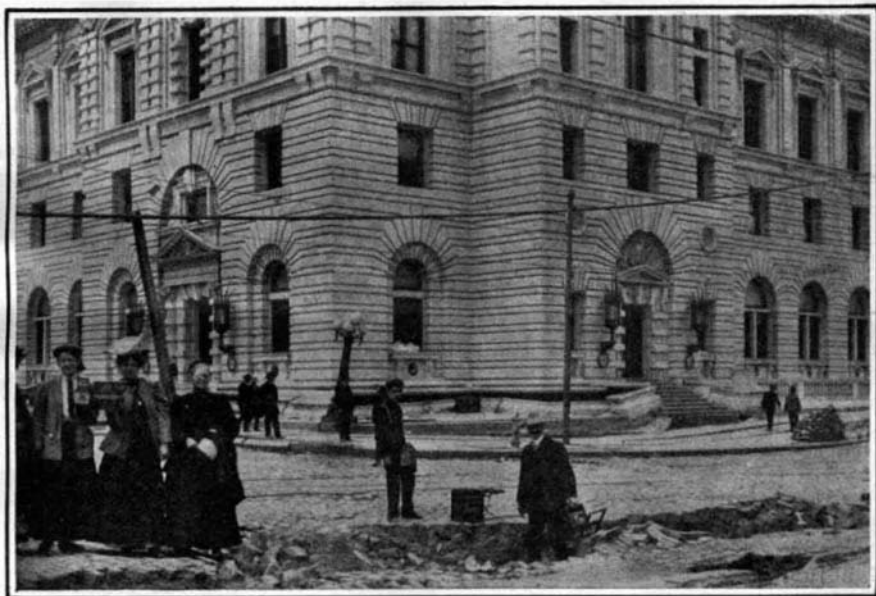
The illustration of the post office presents a very remarkable contrast; for while the building itself appears to be in perfect line and level, except in one corner, not shown, which was built over a swamp, the adjoining ground and all parts of the masonry of the building that were not carried by the building foundations proper are greatly upheaved and distorted. How comes it that the building should have stood so unmoved, while the surrounding *terra in-firma* was tossing like the waves of a troubled sea? The paradox is to be explained by the fact that while the sidewalks and streets rested upon either made or filled-in ground, or upon alluvial deposits formed in the ordinary course of nature, the important buildings of San Francisco such as this stood generally upon foundations which reached down to the underlying rock, or to a bearing upon a stratum which in immobility and sustaining power was equivalent to rock. It is possible that when the seismic tremors passed through the earth, there was no great permanent displacement of

The Post Office Suffered Little. Only Sidewalks Are Twisted. Note Fissure in Which Man Stands.

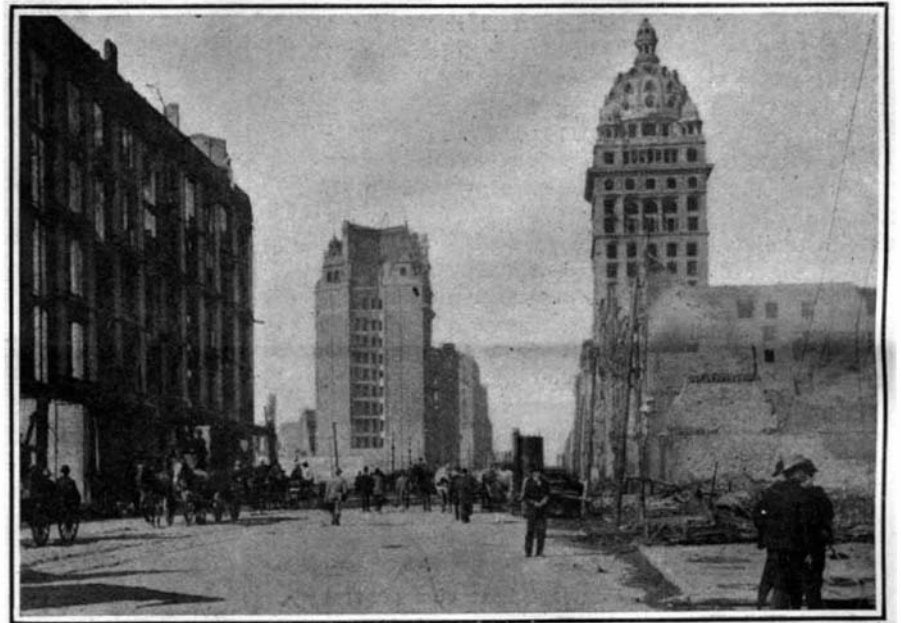
At the present writing, all the evidence at hand goes to show that, in spite of the severity of the shock, the steel frame of the tall office building has come through the ordeal triumphantly. Moreover, in spite of the earlier accounts to the contrary, it now appears (and the accompanying photographs bear out the statement), that the masonry walls, and presumably the fireproof floors, were not shaken loose from the steel framing—not at least, in the tall office and other business buildings. Proof of this, as far as the walls are concerned, is clearly seen in our view showing the Call Building and the new quarters of the Mutual Bank. This fortunate result is to be attributed to the more thorough system of tying the walls to the structure, which characterizes the construction of the latest buildings of this class.

View Showing How Well Steel-and-Masonry Buildings Stood the Test of Earthquake and Fire.

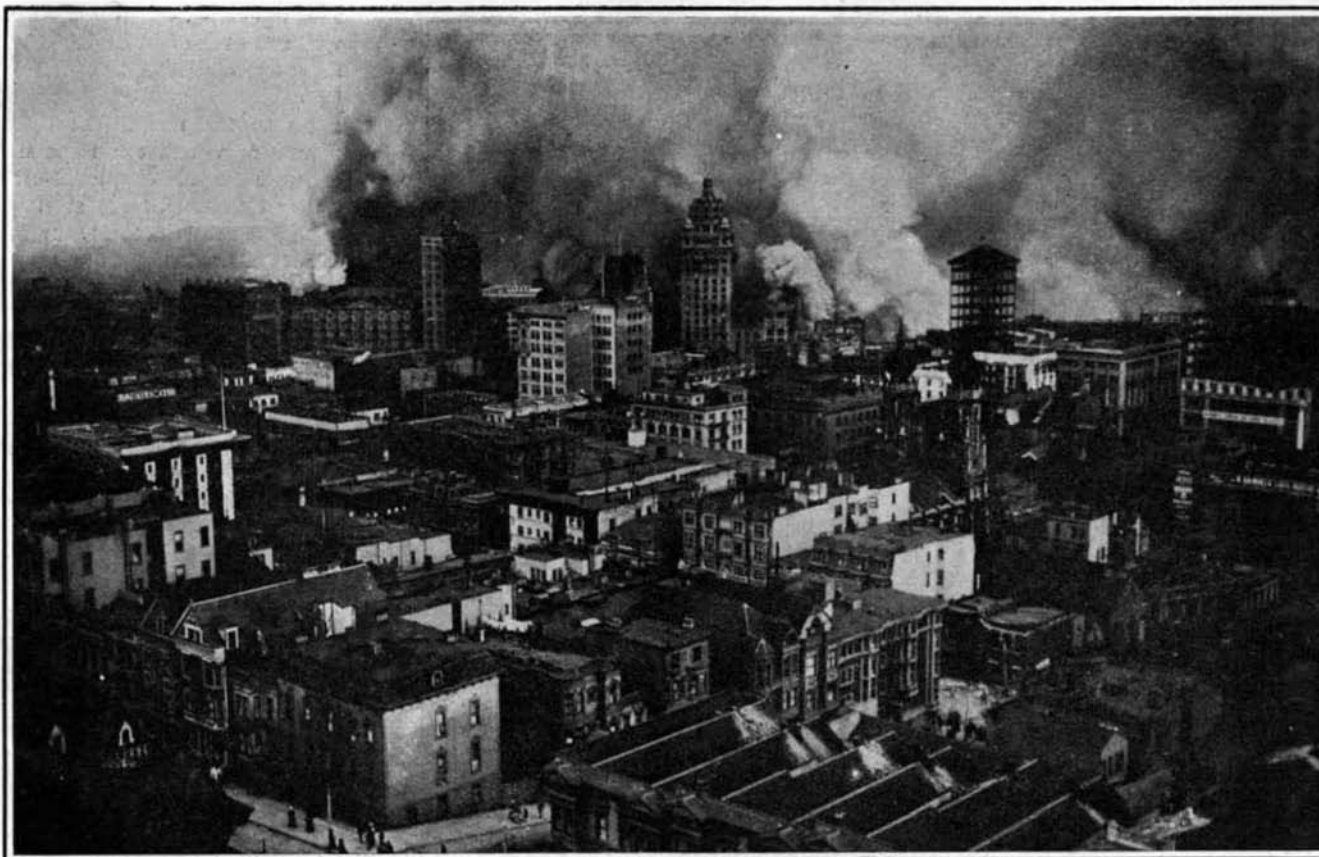
After all is said and done, it was undoubtedly the fire and not the earthquake that destroyed San Francisco. This is evident from a study of the photograph taken from the hills back of San Francisco, showing the destruction of the business section. The only visible evidence of the earthquake is the fallen chimneys; the wooden buildings, at least in this section of the city, appearing to be but little harmed. The earthquake did its work in smashing the water mains and cutting off the water supply, and the fire

The Burning of the Business District as Seen from the Hills.
