THE EARTHQUAKE AND THE TRACKS OF A TROLLEY LINE.

FIREPROOFING AT SAN FRANCISCO.

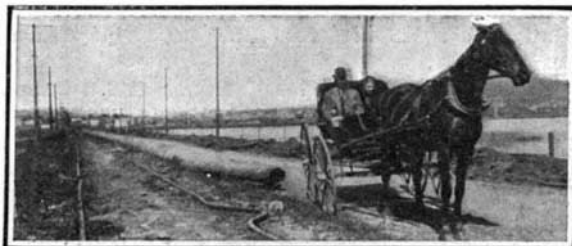
Rails Buckled by the Earthquake.

In the accompanying two illustrations, which were kindly furnished by a subscriber, the effects of the compression are admirably shown in the bending of the rails of a trolley line leading out of San Francisco. Each rail may be said to have been pushed longitudinally from each end, with the result that it bent. Hold one end of a wire in each hand; push your hands together, and a like effect will be produced. If the wire is very long it will buckle at several points. In the case of the railroad the buckling occurred over a distance of about three miles.

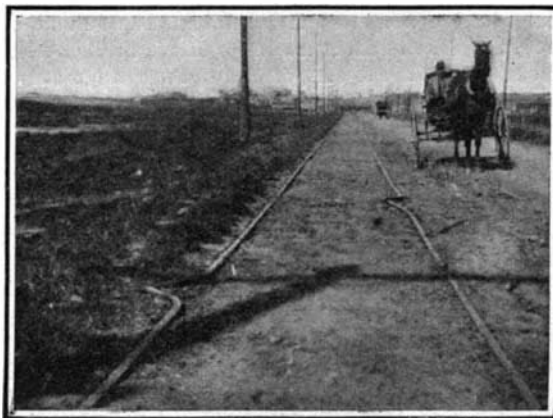
Effect of Longitudinal Compression on Rails.

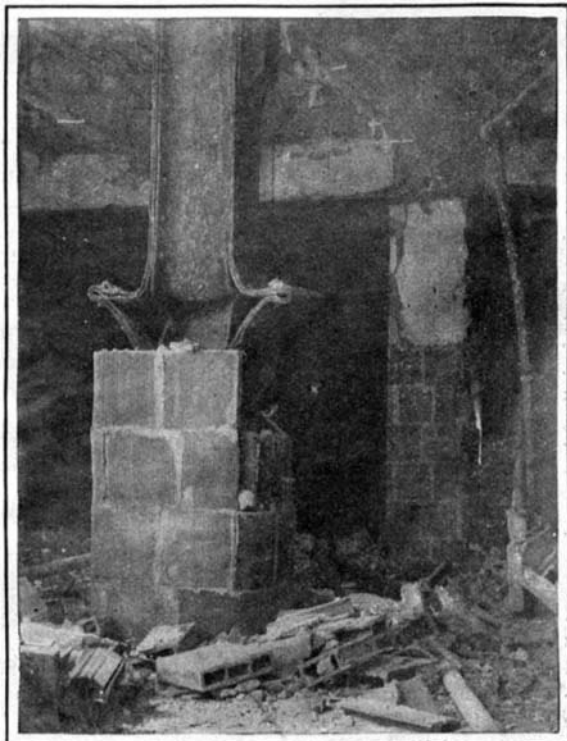
In our various articles on the fire we have strongly advocated the use of concrete as being the material which presents the most perfect fire-resisting qualities, and it so happens that in a comparison of two of the photographs sent us by our correspondent, our readers will find a most striking proof of the correctness of this view. We refer to the two views which were taken in the basement of the Ahrensen Building. Photograph No. 1 represents a steel column in this basement, which was supposed to have been rendered fireproof by incasing it in hollow tile. The tiling was stripped off by the heat, or possibly by the shock of the earthquake (although on this point we have no information), and under the weakening action of the fire the column has telescoped on itself for a distance of 10 or 12 inches. Sixteen feet distant from this column is another, which had been fireproofed by incasing it in concrete; but although it must have been exposed to the same shock and the same heat, the concrete is still in place, apparently in perfect condition, and the column within it is presumably uninjured. Just how great a heat it must have endured, may be judged by the condition of the sidewalk lights and beams, the beams being bent down, and the lights being partially melted and hanging from the beams like icicles.

Fig. 1.—Column Incased in Hollow Tile, Stripped of Its Covering, and Buckled, Sinking 12 Inches.

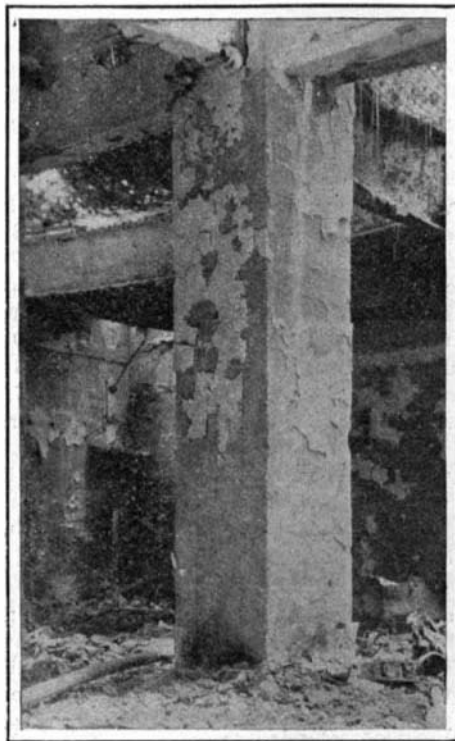
Fig. 2.—Column, 16 Feet from Column in Fig. 1. Incased in Concrete, Was Not Injured.

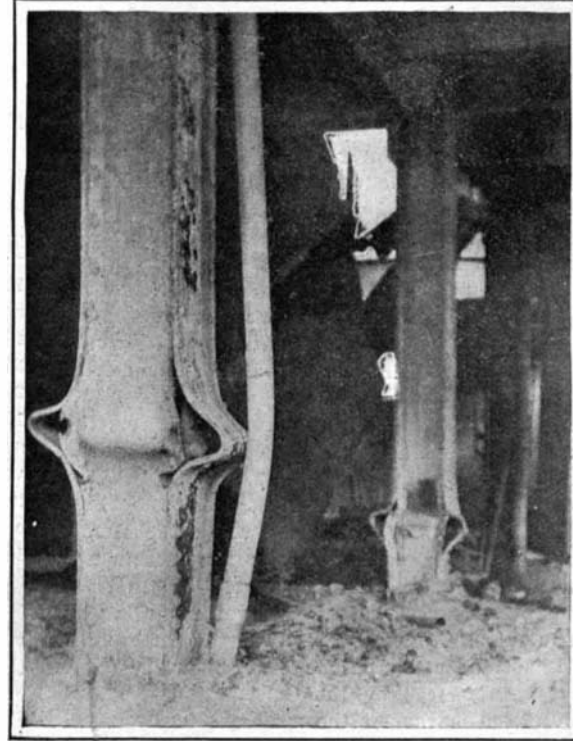
Fig. 3.—Non-Fireproofed Columns in Monadnock Building, Buckled and Shortened 10 Inches.
