THE PROTECTIVE WORKS OF THE ASSOUAN DAM.

BY OUR LONDON CORRESPONDENT.

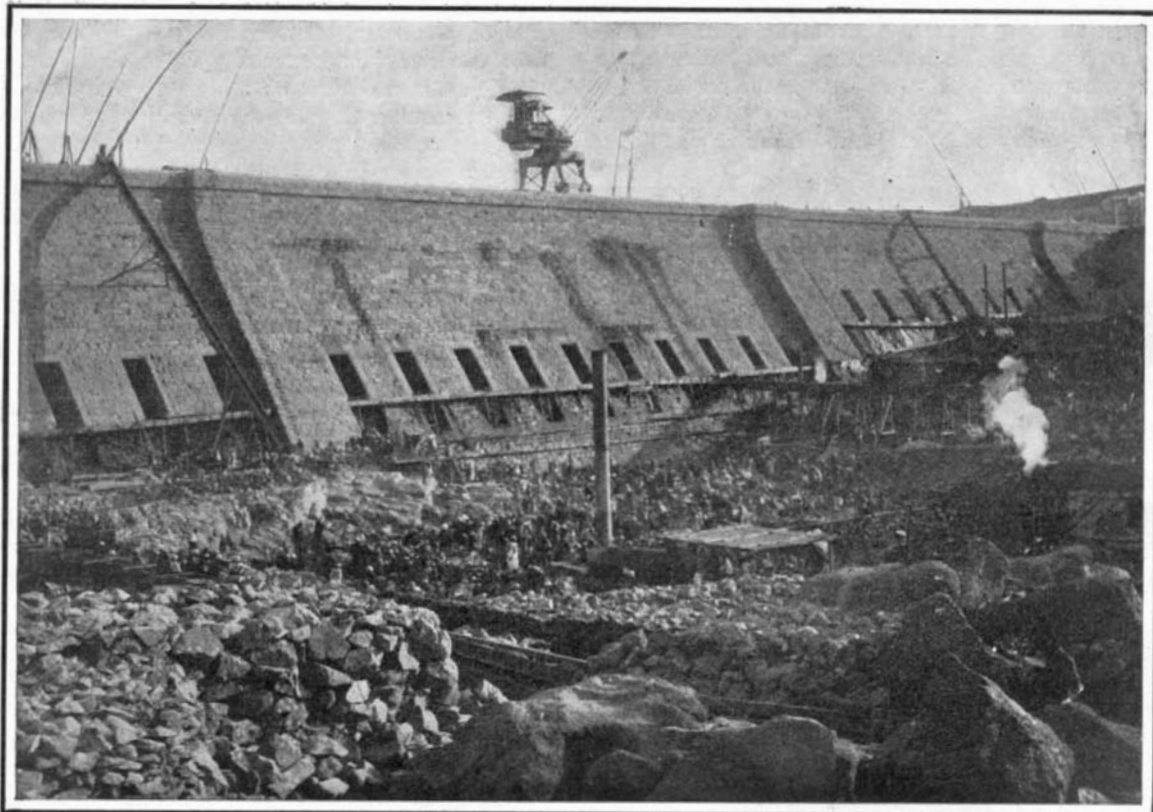
Excavating 350,000 Cubic Yards of Loose Rock and Gravel from the River Bed, Preparatory to Building the Masonry Apron.

Note in foreground huge masses of rock torn from river bed by the rush of water from the sluices.

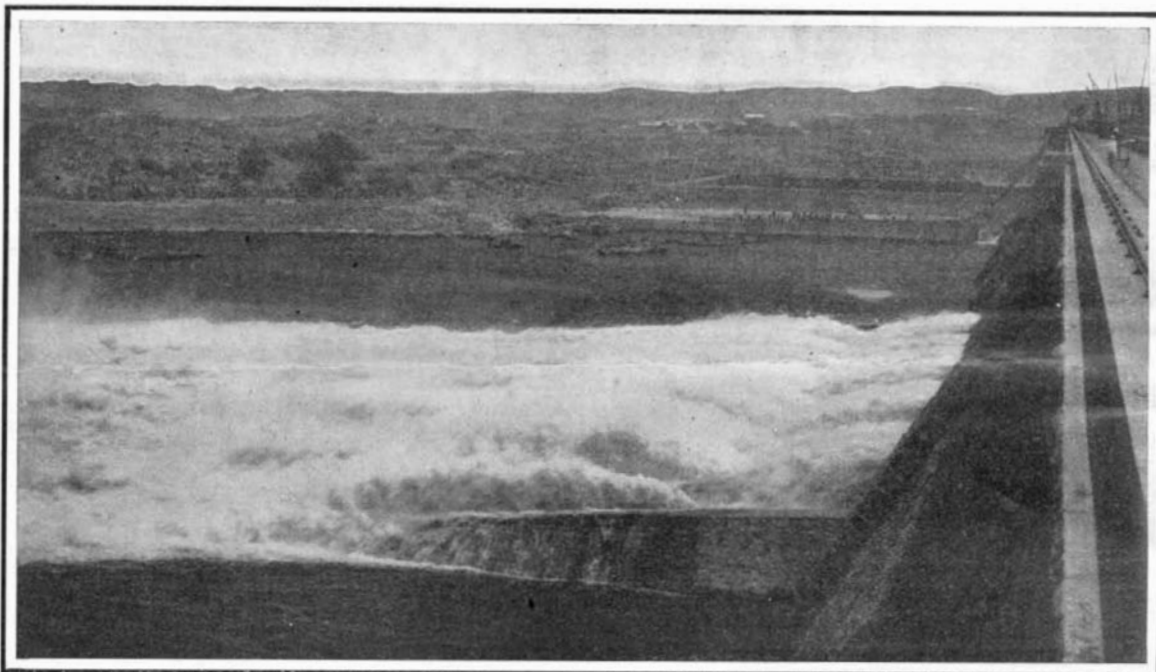
Testing a Portion of the New Protecting Apron Below the Dam. Note the Violence With Which the Water Rushes Through the Sluiceways.

When the work was completed the apron was subjected to test, the water pressure at first being comparatively slight, and the head being gradually increased until the maximum was attained. At intervals, the various sets of sluices were shut off, so that the effect, if any, of the heavy impact of the water flowing through might be ascertained, and in order to repoint up immediately any joints that might have been washed out in the first instance owing to defective construction. Out of the whole 290,630 square feet of talus completed in the first half of the work, only about 1,000 square feet failed to resist the maximum head of water that could be delivered upon it; and in view of the enormous area so covered, the failure of this small portion, considering that native labor was employed, was not surprising. Owing to the lateness of the season, the point at which the failure occurred could not be reached until the following

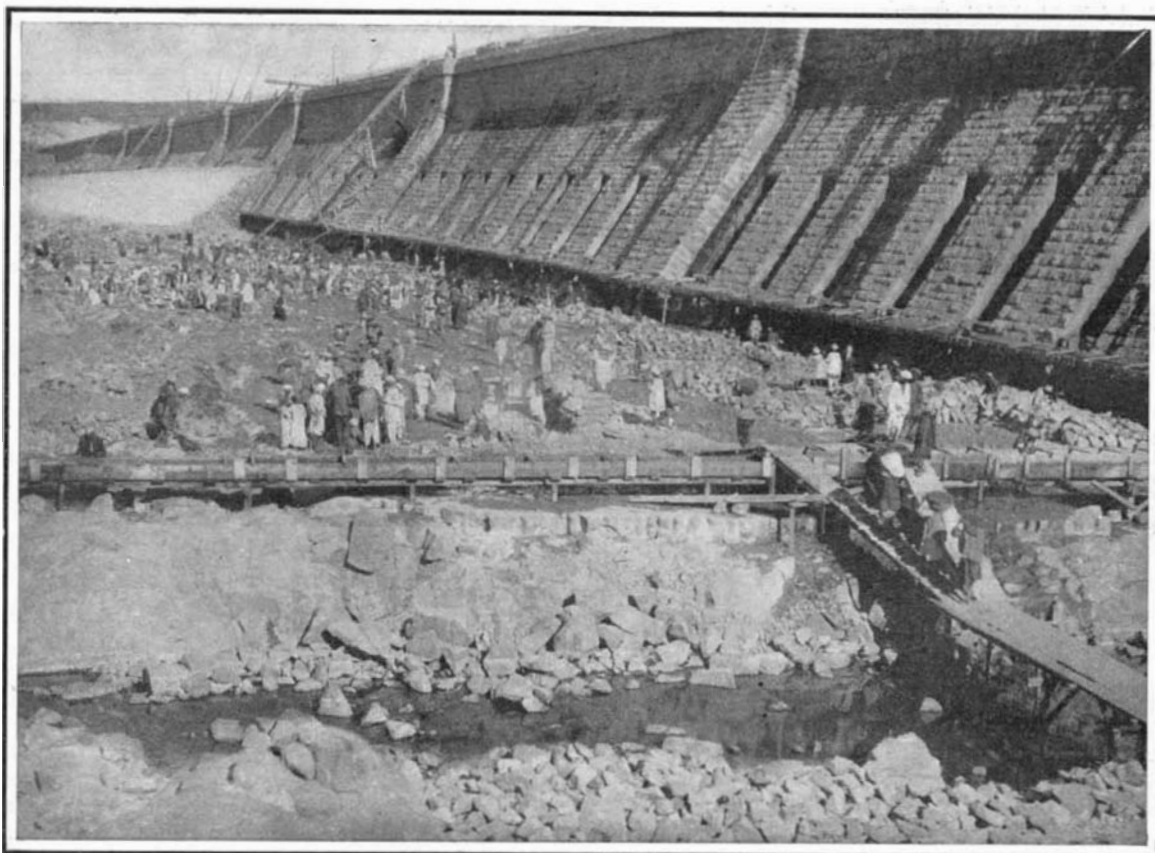
Building Up the Excavated River Bed With 405,000 Cubic Yards of Solid Rock Masonry Paved With a Granite Facing, Which Is Carried Up to the Lips of the Sluices, as Shown.

The whole of this masonry was then faced with squared, fine-grained, granite blocks. These blocks were 15½ inches deep, with heading courses in four sets, 31½ inches deep, and they were all laid in a 2 to 1 cement mortar. Altogether, the total area of facing completed for the sluices sets 1 to 8 amounted to approximately 290,630 square feet. A comprehensive idea of the magnitude of the task involved in the carrying out of the protective work may be had from the fact that the building of the talus across one-half of the barrage entailed the building of 517,350 cubic feet of sadds, the excavation of 1,818,671 cubic feet of soft ballast, and 3,566,254 cubic feet of rock. For filling up 1,165,362 cubic feet of rock and 3,135,494 cubic feet of rubble masonry were used. There was 288,937 square feet of facework and 53,820 square feet of pointing.
