#### WRECK OF AN ELECTRIC TRAIN ON THE NEW YORK CENTRAL.

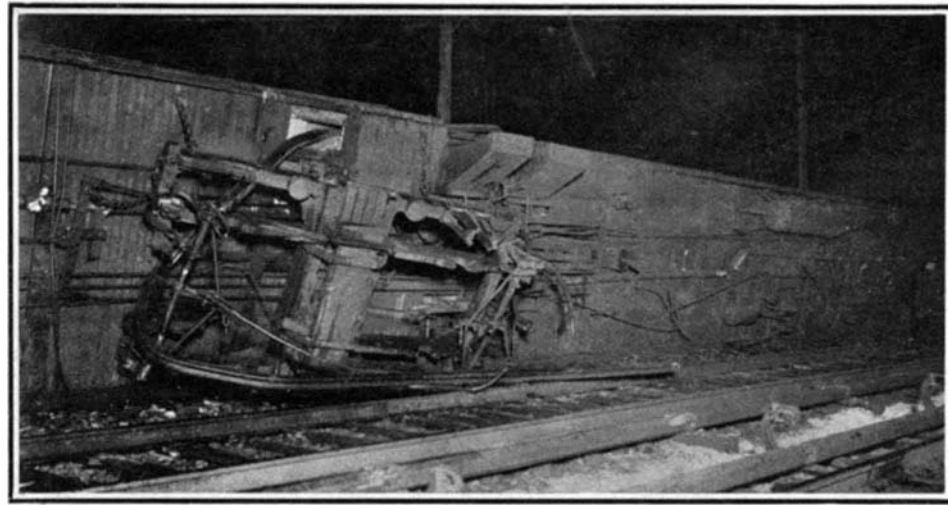
The train was made up of two 95-ton electric locomotives, followed by a combination baggage and smoker car and four ordinary day coaches. The weight of the two motors was about 190 tons and of the five cars about 200 tons. The condition of the track after the accident, the scoring on the ties made by the derailed wheels, and the fact that the two locomotives did not leave the rails, would indicate that the outer rail was driven out of place by the locomotives as they swept along the curve, and that as the cars reached the same rail they left the track, and tore through the adjoining third rail (which was stripped from its place and in some places wrapped around the trucks and even driven up through the cars, as shown in one of the accompanying illustrations), the cars finally overturning and sliding along upon their sides until their momentum was expended. It was during this last period that the fatalities occurred; for the passengers, being thrown against and through the broken windows on the lower side, were ground between the cars and the tracks as between the upper and the nether millstone.

Bottom View of One of the Overturned Cars, Showing a Length of Third Rail Wrapped Around the Truck and Driven up Through the Bottom of the Car. Another View of This Rail Shown in Cut Below.

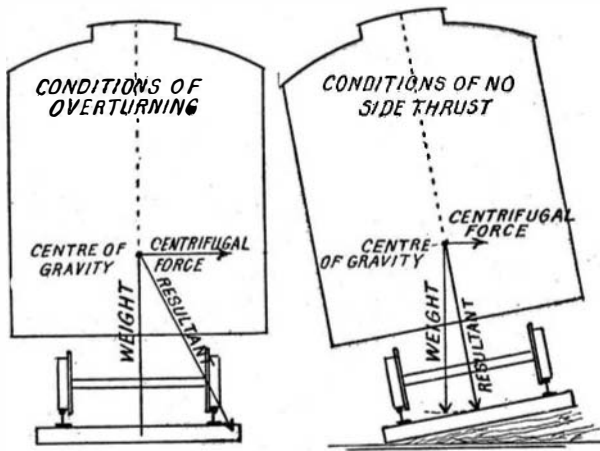
The elevation of the outer rail above the inside rail is done in obedience to Newton's first law of motion, according to which a body will continue in its state of uniform motion in a straight line unless compelled to alter that state by force impressed upon it. Thus, when a train enters a curve, its tendency under this law is to continue to run in a straight line, and the "force impressed upon it" is represented by the reaction of the outside rail of the curve, which thrusts the train laterally from the straight line, with a pressure which increases directly in proportion to the weight of the train, in the inverse proportion to the radius of the curve, and directly as the square of the velocity with which the train is moving. This product of the weight, speed, and curvature is known as the centrifugal force; and when a train is running on a curve which has no elevation of the outer rail, a point is soon reached at which the resultant of the weight of the train acting vertically and the centrifugal force acting horizontally, will pass outside of the outer rail and result in the overturning of the train, or the climbing of the wheels over the track, a condition which is represented in one of the accompanying engravings. In order to counteract the lateral centrifugal effect, the outer rail is elevated and the car tilted toward the inside of the curve. If this elevation is of just the right amount for the sharpness of the curve and the speed of the train, the resultant of the weight and the centrifugal force will lie in a direction normal to the track, and the train will have no disposition to bear against either the outer rail or the inner rail. If the elevation is too small for the speed and curvature, the train will bear against the outer rail, and if the elevation is too great, the train will tend to bear against the inner rail.

Now, since the accidents due to jumping the track or the spreading of the rails always occur on the outer rails, it is evident that it would be better to have an excess of elevation rather than otherwise, thus relieving

Approximate Diagrams, Showing the Effect of No Elevation and Full Elevation Upon the Stability of Trains on Curves.

Now that electric locomotives are being introduced on steam railroads, we believe that special attention must be given to the question of maintaining curves at their proper alinement and elevation. Every maintenance-of-way engineer knows that the traffic tends to throw the curve out in both of these respects. For such service, it would be a good policy to elevate on curves for the maximum speed. Moreover, for the guidance of trackmen, it would be an excellent and not very expensive provision to place stone or iron bench marks and centers at every 100 feet around such curves; for these, being permanent, would give the trackmen a constant and reliable reference mark, and would obviate the necessity for their dependence upon the occasional visit of the engineer with his transit and level.

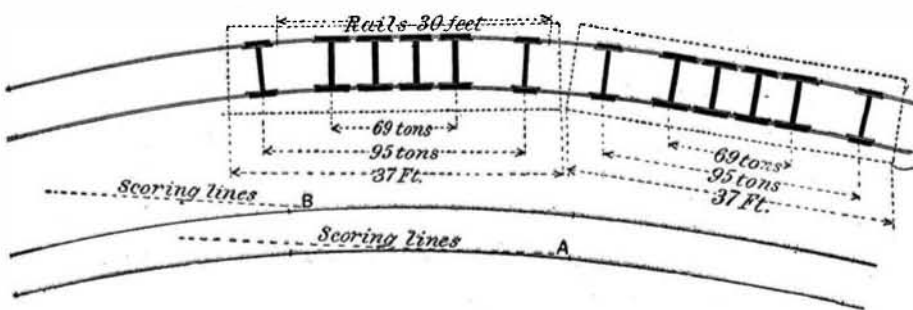
outer rail at the point of derailment had been neatly sheared off between the outer edge of the base of the rail and the tie-plates. Opposite the commencement of this rail, the ties on the inside of the curve were scored, while those on the outside were intact; which is clear proof that the outer wheels remained on the displaced rail, and jumped the track at the end of it, where the scoring of the ties on that side begins to be visible.

The fact that for many years steam locomotives, heavier than these electric locomotives, have been hauling heavier trains than this one around these curves at speeds which were frequently between 60 and 70 miles an hour, without the occurrence of any accident of this kind, naturally points to the conclusion that there must have been something in the conditions on this train which produced heavier lateral stresses upon the outside rail than occur on steam-operated trains. If this be so, these conditions must lie in the locomotives, for the train was a light one. Why should these electric locomotives exert a heavier, or, rather, a more destructive, thrust against the rail than do the steam locomotives? The answer will be found in the accompanying diagram showing the two locomotives, from which it will be observed that 69 tons of the weight, being on the drivers, is concentrated within a space of 12 feet, and that the whole 95 tons

weight of each locomotive is concentrated upon a single rail length and the whole 190 tons weight of the two locomotives upon two rails' length. Although this is not a heavier average per foot, and, indeed, not so heavy, as that of some of the steam locomotives, it is

Upper Diagram Shows Relation of Weights and Length of Locomotives to Length of Rails Lower Diagram Shows Scoring of Ties at Point Where Outer Rail Was Spread.

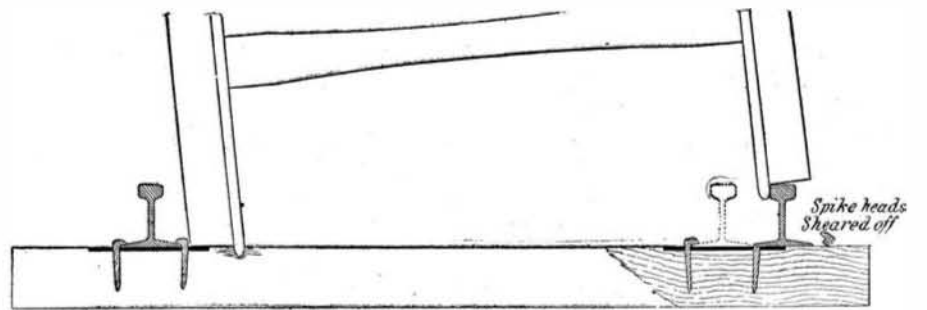
In the case of the accident on the New York Central, an inspection of the curve on the morning after the accident, when the track had been once more put in shape, showed that the spikes on the outside of the

Sectional View Showing How the Side Thrust Caused Outer Rail to Shear Off Spike Heads Between Edge of Rail Base and Edge of Hole in Tie Plate.

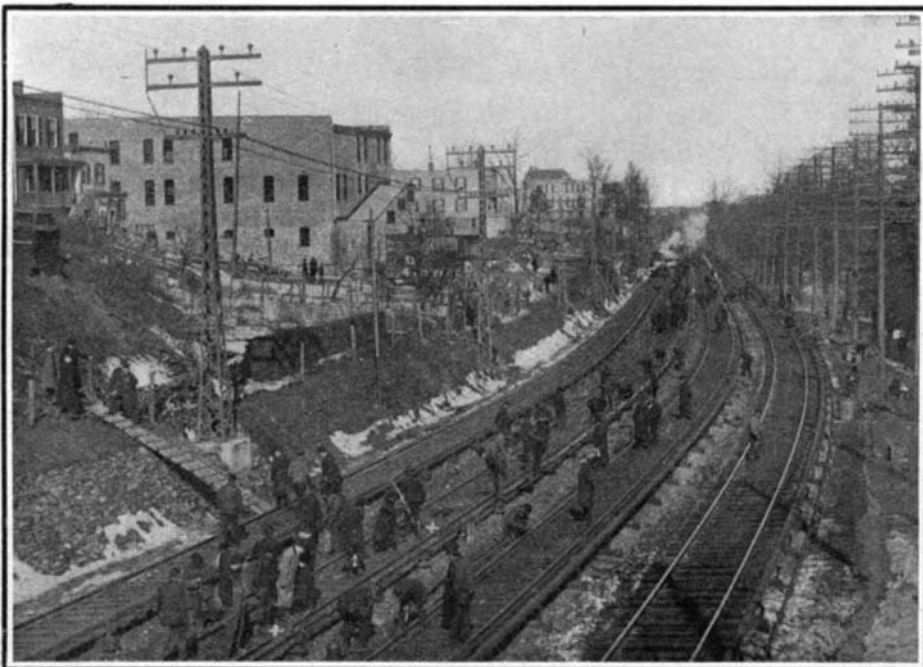
To take the case in point, the curve on which the accident occurred was an easy one, being of only three degrees variation from a tangent in every 100 feet of length. It called for a  $4\frac{1}{2}$ -inch elevation of the outside rail, and under these conditions the centrifugal force would be about balanced on a train running at the speed of 46 miles an hour. At speeds above this the train would crowd against the outside rail with a pressure which would increase as the square of the velocity, and in the judgment of the engineers this speed could be run up to as high as 65 miles an hour without endangering the train. This, they claim, is the general railroad practice throughout the country. Now the reason that steam railroad tracks are not elevated for the highest speed is that slow trains are sometimes run over express tracks, and it is considered that the best compromise is to elevate the outside rails for the mean speed.

An inspection of the new rail, after the tracks were cleared up, suggested that there was a slight flattening of the curve at this point; that is to say, that the line of this rail lay somewhat inside of the true curvature. If this were so, it must follow that when the rigid group of four drivers on the first motor struck the rail, its natural effort would be to iron out the flat spot, as it were, and that it was in the effort to do this that the spikes on the outside were sheared off in succession as the motors swept by, and the whole rail pushed over into the position shown in one of our illustrations.

Curve on Which Accident Occurred. Spread Rail Shown by Two Crosses.

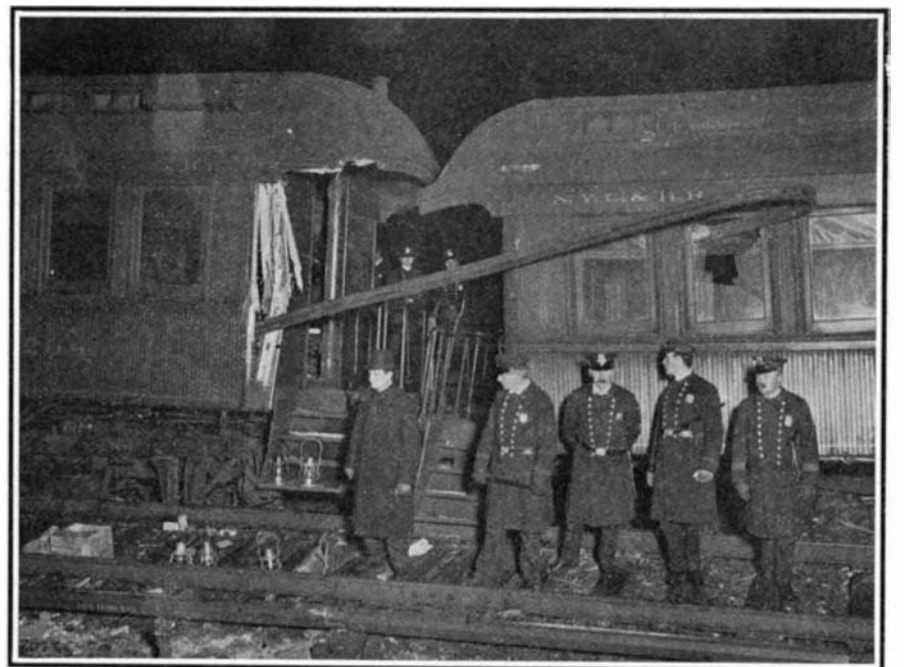
View After Cars Were Righted. The Third Rail Driven up Through Bottom and Side Post of First Car and Into Window of Second Car.
