**COLLAPSE OF A LARGE GAS HOLDER.**

In the accompanying illustrations are shown the extraordinary ruins of a large gas holder which collapsed during its trial test on the afternoon of Tuesday, December 13. The wrecked structure had recently been built for the Consolidated Gas Company, of New York, on a portion of their property lying between First Avenue, Avenue A, Twentieth and Twenty-first Streets.

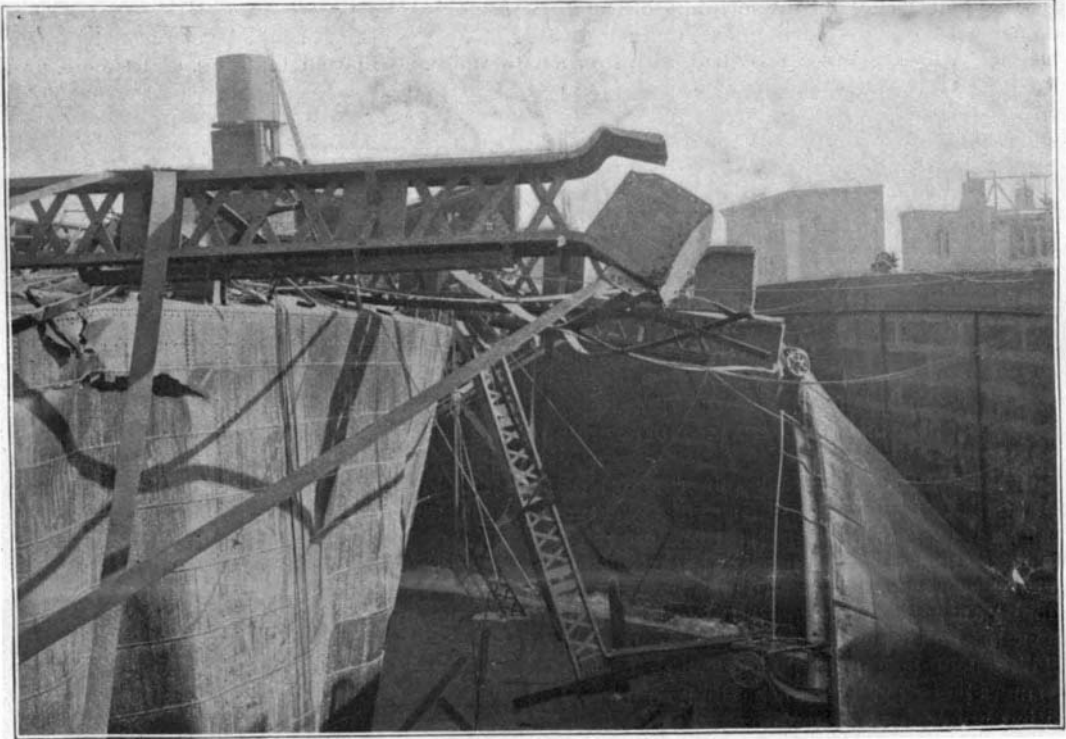
1.—TOPMOST SECTION OF HOLDER, WITH PORTION OF FRAME FALLEN ACROSS IT.

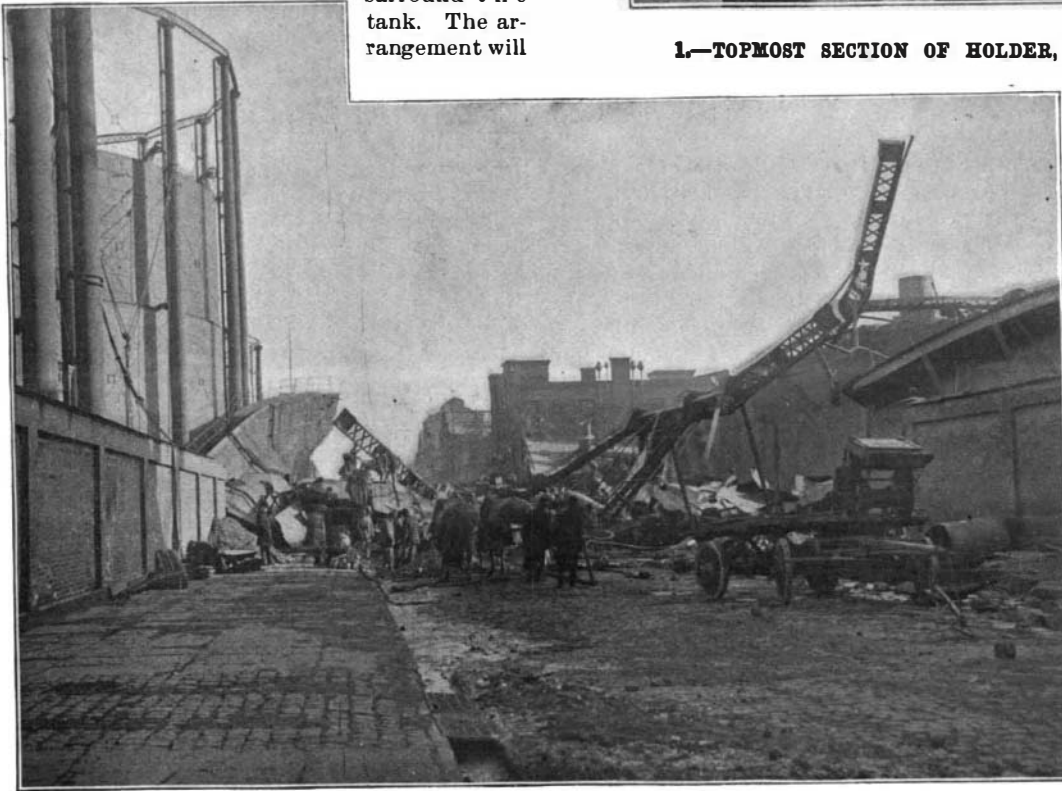
2.—WRECKAGE OF THE FRAME LYING ACROSS TWENTY-FIRST STREET.

The structure was being tested by filling it with air, when, at 5:30 in the evening, the wall of the tank on the north, or Twenty-first Street side, split open from top to bottom. The water rushed out in enormous volume, filling Twenty-first Street to a depth of several feet and flooding the neighborhood for several blocks around. The wall of the tank being split, it fell outward under the pressure, knocking away the posts of the guide frame, which fell in a tangled mass across the holder, the ruins of the frame reaching clear across Twenty-first Street and falling upon the holders in the adjoining lot (see Fig. 2). It is probable the fall of the guide frame was preceded by the dropping or telescoping of the holder, the various sections or lifts of which can be seen lying within one another in Figs. 1 and 3. The rush of water carried away the inclosing wall of the gas company's property, and eyewitnesses describe the "blast" as having been responsible for the wrecking of several buildings in the vicinity.

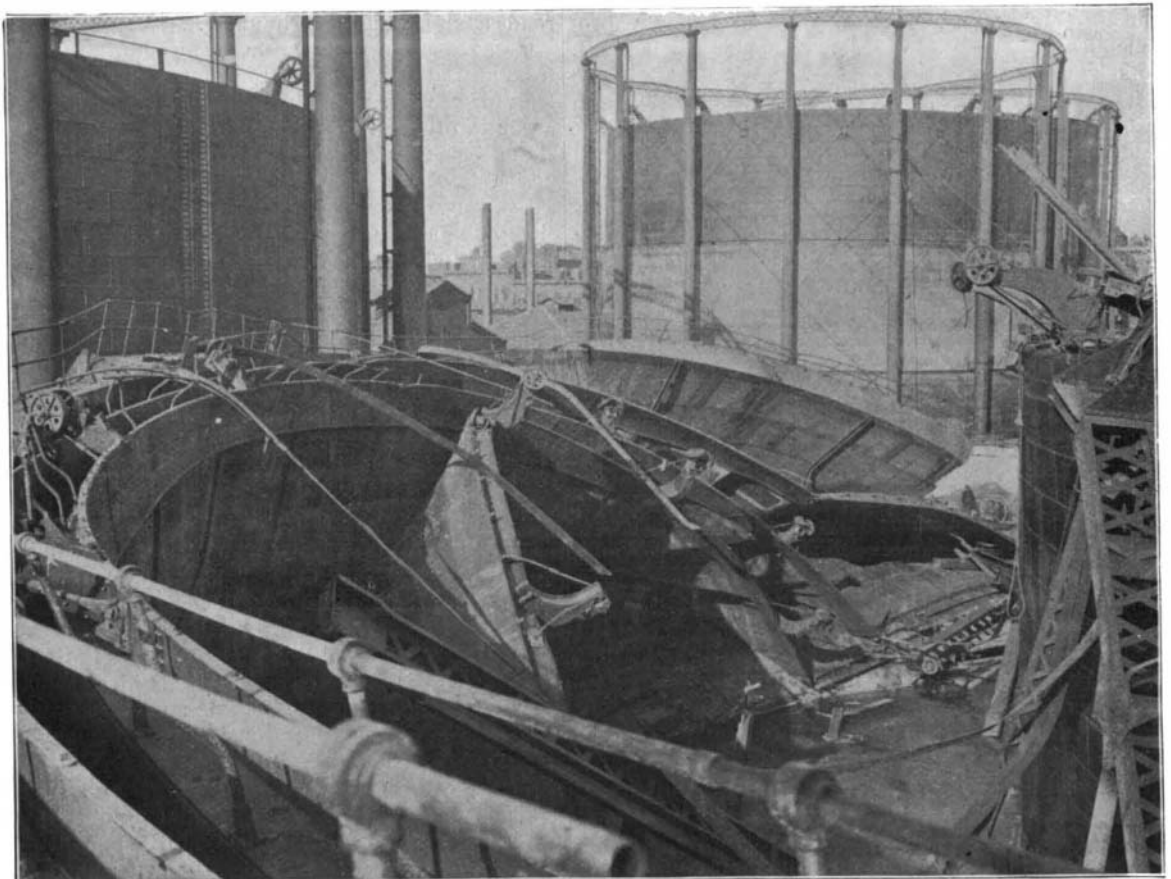
At the present writing the cause of the disaster is a profound mystery. The design of the structure was of a standard and well approved type, and as far as can be judged the material was of good quality. Some of the phenomena of the wreck, such as the blowing of material to a considerable distance, point to the possibility of gas having entered the holder with the air and formed an explosive mixture. The result of the investigation which is now being carried on will be looked for with considerable interest.

The wrecked structure was of the telescopic kind, and the holder was built in four sections. The water tank, which was built of mild steel, was 42 feet deep and 178 feet in diameter. About one-half of

3.—LOOKING DOWN UPON THE WRECK OF THE TANK AND THREE LOWER SECTIONS OF THE HOLDER.
