#### A NEW SEMI-DRY BATTERY.

#### THE FAILURE OF THE BROOKLYN BRIDGE.

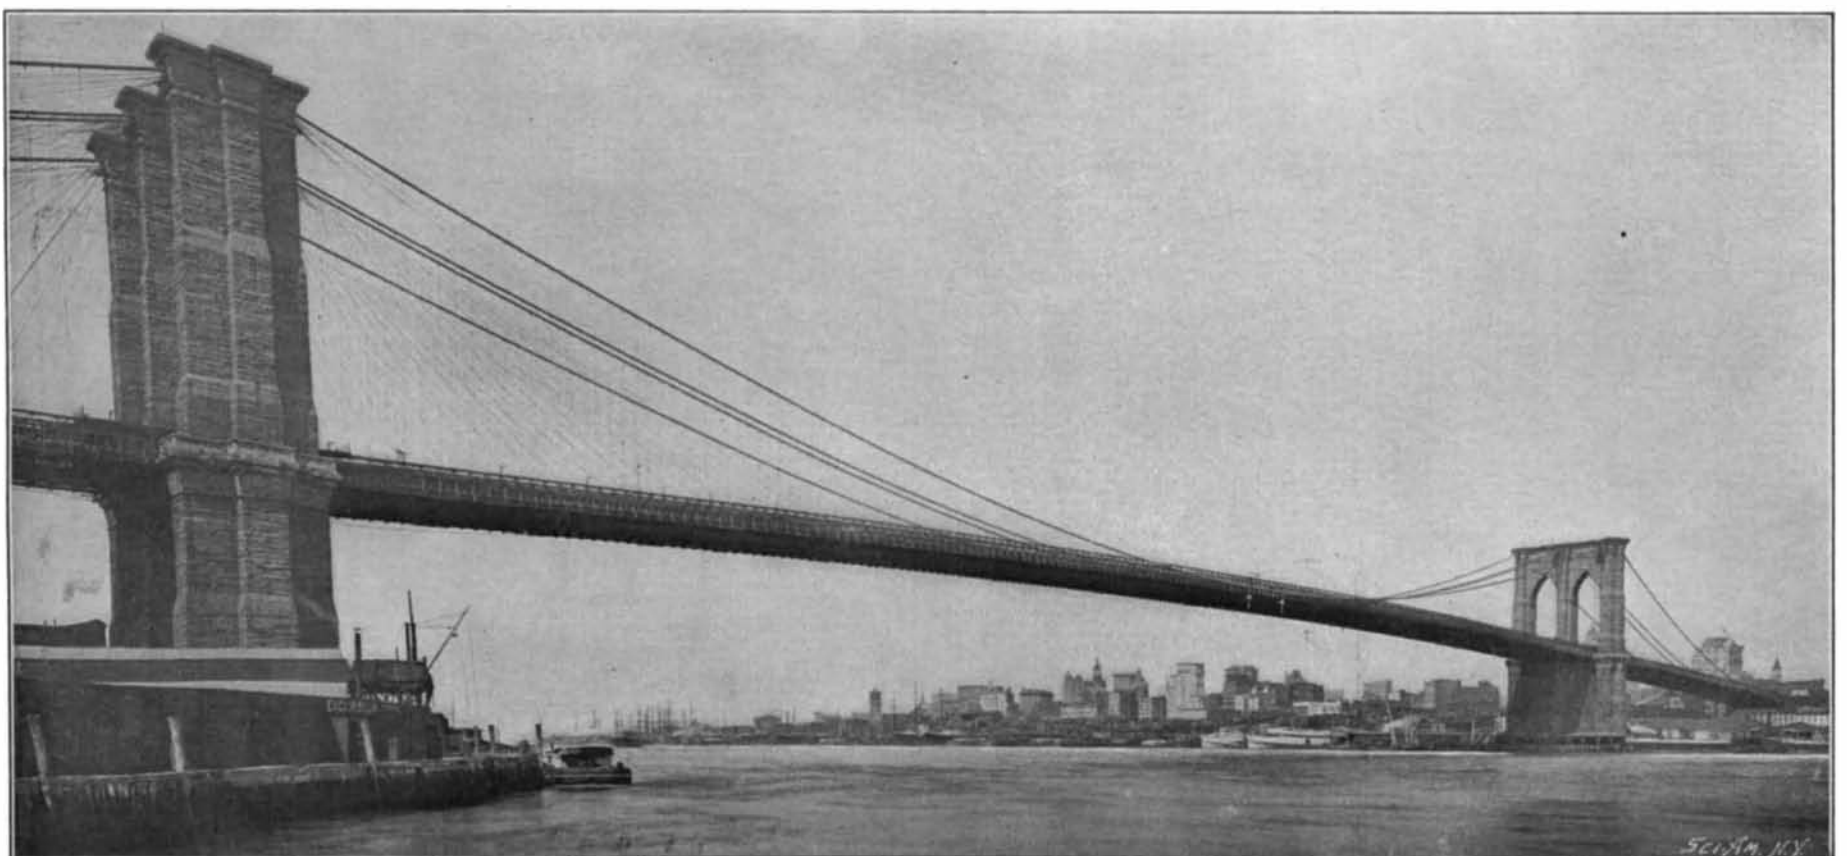
BROOKLYN BRIDGE FROM THE NORTH, SHOWING BY ARROWS AT CENTER, LOCATION OF THE NINE BROKEN SUSPENDERS.

As everybody knows by this time, the accident was due to the breaking of certain suspenders (nine in all) on the most northerly of the four main cables of the bridge. The immediate question to be solved is that of the actual cause of this failure. One of the engineers of the bridge has given out that it was the excessive heat. This is only partly true. The excessive heat was the occasion but not the cause of the disaster. The direct cause is to be found in faulty construction, coupled with the action of the elements. And let it just here be clearly understood that, in spite of the increased load which has been put upon the bridge, it is an absolutely safe structure as regards the four great cables themselves. The suspenders, moreover, by which the roadway is hung from the cables, are amply strong to carry even their present loads, provided these suspenders are subjected only to the simple pull or tensional strain for which they were designed. The floor system (including floor beams, stringers and stiffening trusses), though of antiquated design, and not at all of the kind that would be built in a modern suspension bridge, is sufficiently strong to carry with safety the present weight of the bridge, provided, however—and we cannot lay too much stress upon this—that it is subjected to a very thorough and frequent system of inspection in all its parts. We have said that the suspenders are amply strong for their work; but in saying this we draw attention to the fact that the method of attaching the suspenders to the floor system, particularly at the center of the main span, is poor and cheap in design, and liable to rapid deterioration unless it is carefully watched and frequently painted.
