EXPLOSION OF DYNAMITE AT THE RAPID TRANSIT SUBWAY.

DYNAMITE EXPLOSION ON RAPID TRANSIT SUBWAY.

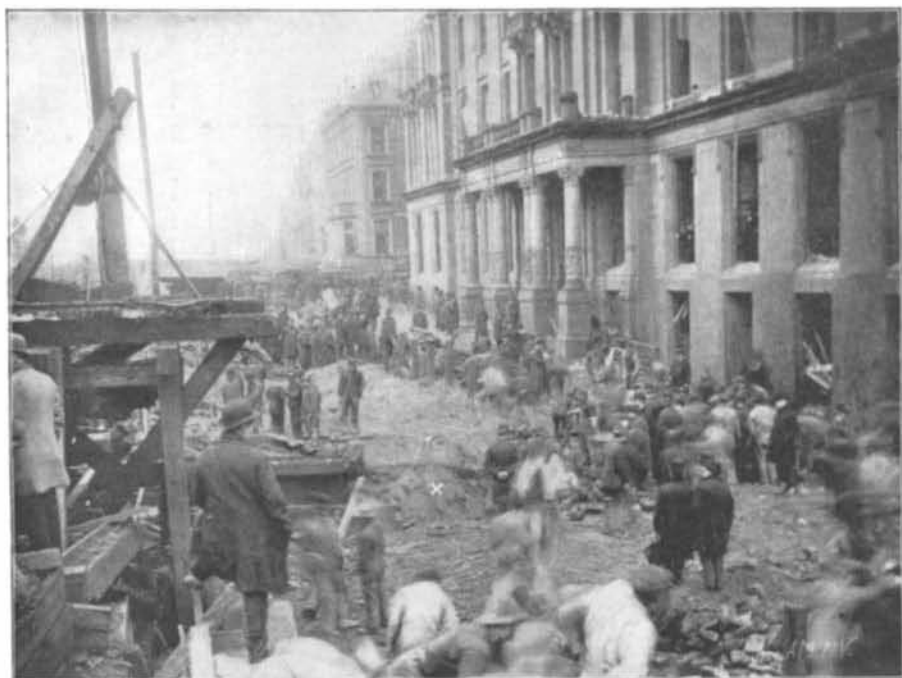
Looking South on Park Avenue. Cross Indicates Location of Dynamite.

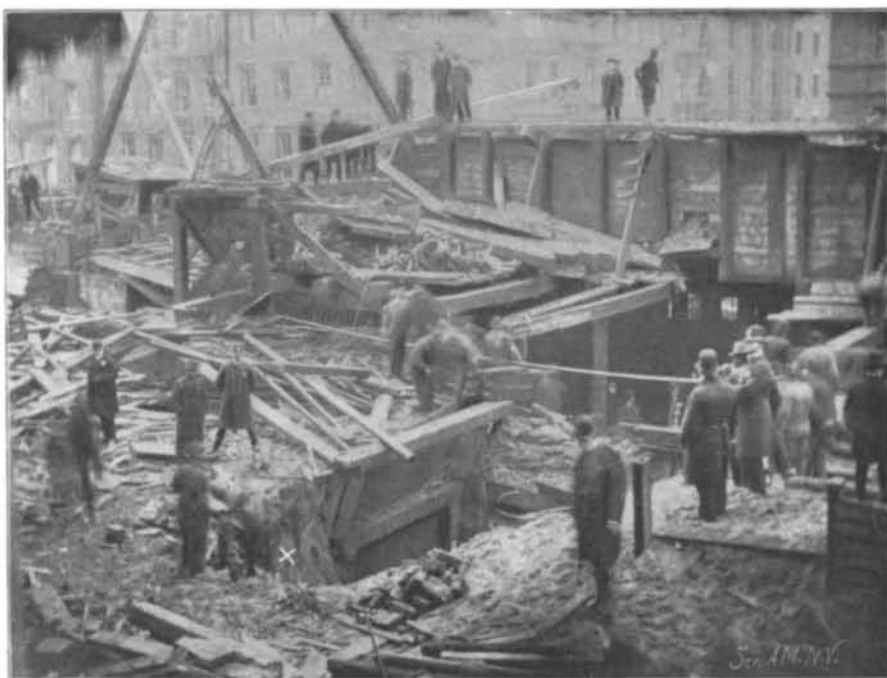
Exact Locality of Explosion Showing Openings into the Subway and Park Avenue Tunnel.

day's blasting. The shanty stood at the surface of the street and not far from the railing which guards the street from the open cut by which the street railway tracks emerge from the mouth of the old tunnel as they approach Forty-second Street station. From the shanty to the front wall of the Murray Hill Hotel was a distance of about 25 feet.

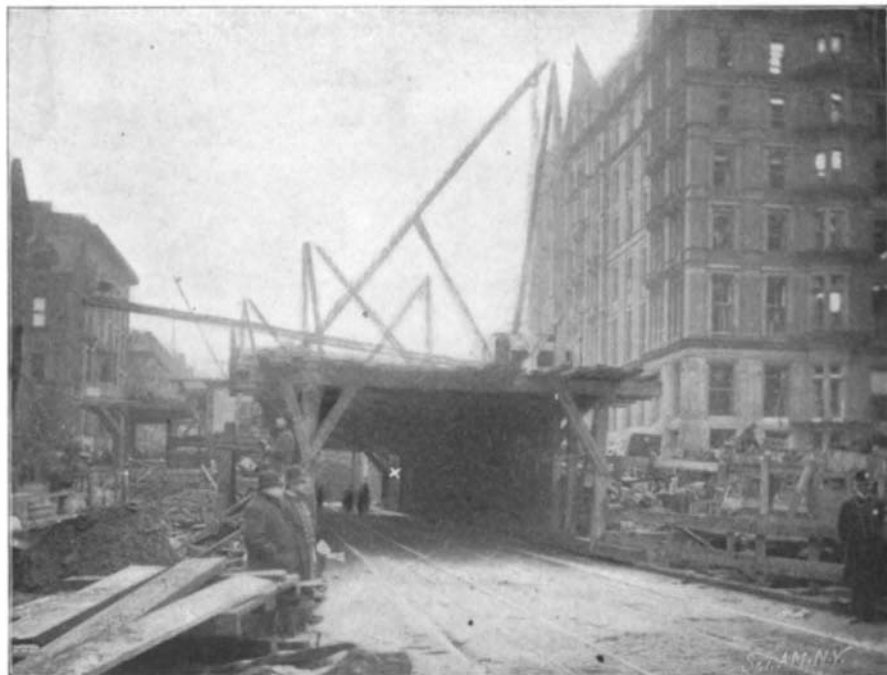
Looking South Toward Park Avenue with Subway Excavation at the Right of Tunnel.

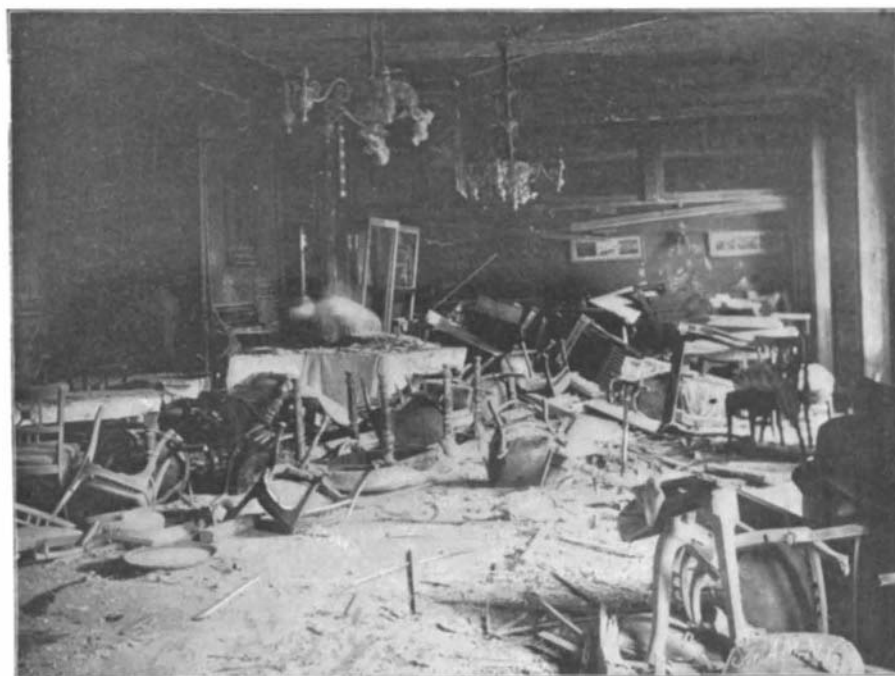
View Inside Murray Hill Hotel Cafe Immediately After Explosion.

Although the results were disastrous, they were not nearly as fatal as one might have expected from the ordinarily crowded condition of the streets at this hour. In all five persons lost their lives, three of them in the Murray Hill Hotel, and two or three hundred persons, the exact number of whom will never be known, were more or less injured. No great damage was done to the Rapid Transit Subway, the loss being confined to the destruction of a derrick and hoisting engine and some platforms and timbering of the tunnel shaft. The most serious destruction was that wrought on the adjoining buildings, and particularly the Murray Hill Hotel. On this building the force of the blast was sufficient to shatter not only every window, but practically every window-frame from street line to cornice. A mass of mud, earth, and splintered timbers was hurled into the nearest rooms, and the glass wreckage and blast of the explosion overturned furniture, wrecked the chandeliers and brought down large portions of the ceiling. The condition of the interior of the hotel may be judged from the photographs which are herewith presented. One of the fatalities occurred in a bedroom immediately opposite the scene of the explosion, the occupant being buried beneath a mass of rubbish, while another person was killed at the cigar stand. On the opposite side of Park Avenue the windows of the Manhattan Eye and Ear Infirmary were completely shattered, the same effects being produced on the Grand Union Hotel.

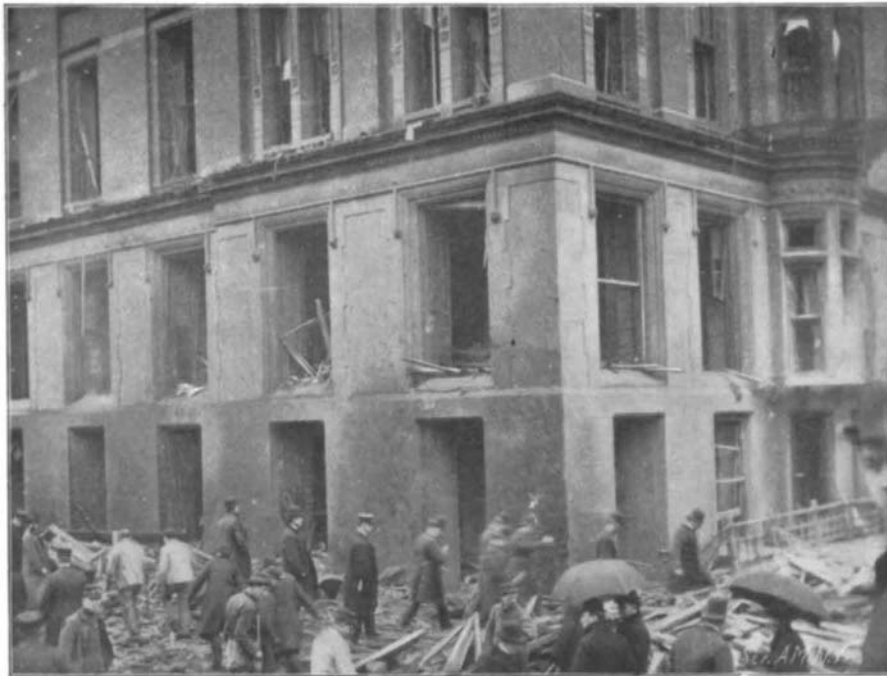
Northeast Corner of Murray Hill Hotel, Which Felt Full Blast of Explosion.

A curious effect, noticed immediately after the explosion, was a heavy piece of planking which had been driven through the cornice of the tower of the Murray Hill Hotel and hung in this position over 100 feet above the sidewalk. Another incident that attracted much attention was the instantaneous wreck of the two large clocks in the towers which flank the southerly façade of the Grand Central Depot. The clock faces were blown from their setting back into the clockroom. It is a matter for congratulation that, although the explosion occurred within a few feet
