PULLMAN CARS IN A RAILROAD WRECK.

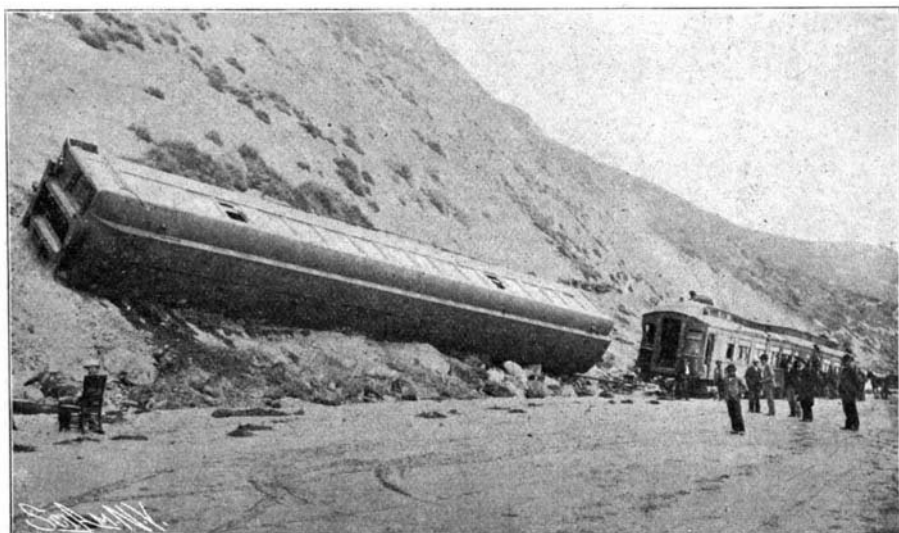
View of the Wreck Taken From the Beach.

The wreck occurred at Punta Gorda, not far from Santa Barbara, Cal., on the line of the Southern Pacific Railway. At the place where the derailment occurred, the track, which is level and on a three-degree curve, runs around the base of the cliffs on an embankment which is 35 feet above the sandy beach of the Pacific Ocean. The train, which was made up of seven cars, was running at a speed of about 35 miles an hour, when the driving wheels of the engine left the rails, and the rear cars after running along for some 130 feet, were wrecked in the manner shown in our illustrations. Strange to say, the pony truck of the engine, the tender, and the three leading cars of the train, kept the rails; the four rear cars, however, consisting of a chair car, a dining car, and a parlor car, followed by a chair car,

jumped the track. The chair car and the dining car rolled down the embankment and finally landed, right side up, on the beach, but minus their trucks. The parlor car turned almost completely over, and came to rest in the position shown in our engraving, lying upon its side on the slope of the embankment. The last car of the train came to rest diagonally across the track, the forward end obstructing the traffic, and the after end being slewed around until it overhung the embankment. The accompanying illustrations speak for themselves and require no detailed explanation; but attention is drawn to the fact that although the cars were moving at the rate of between 30 and 40 miles an hour, and that in rolling over down the bank, the roofs had to endure the tremendous wrench and impact of the 50-ton mass of the car, they proved equal to the task. The interior and exterior views of the chair car show that the roof, as a whole, remained intact, being crushed in only at one point, and there probably by some projecting boulder. The injuries to the passengers were such as would naturally result from their being pitched from floor to ceiling, and from ceiling to floor, as the cars rolled over; and to the wonderful strength of the framing and roof is to be attributed the escape of the

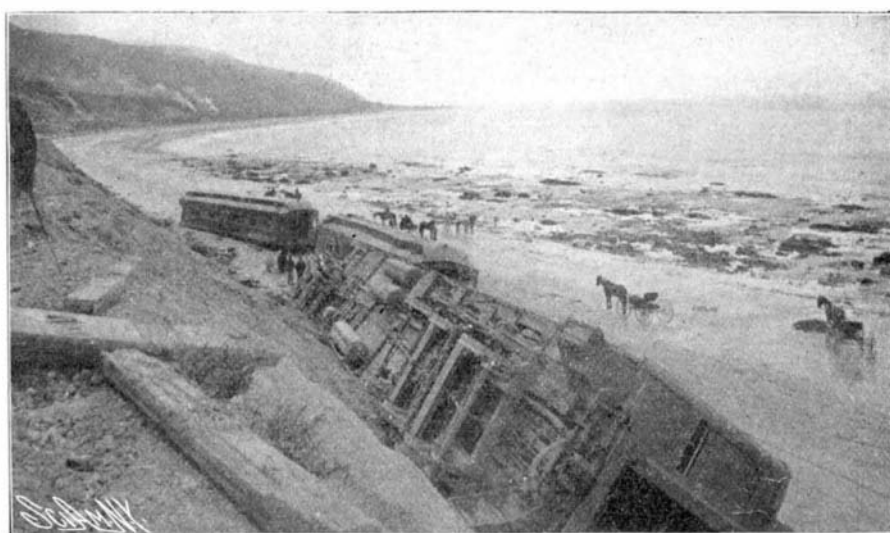
The Wreck Seen From the Railroad Track.

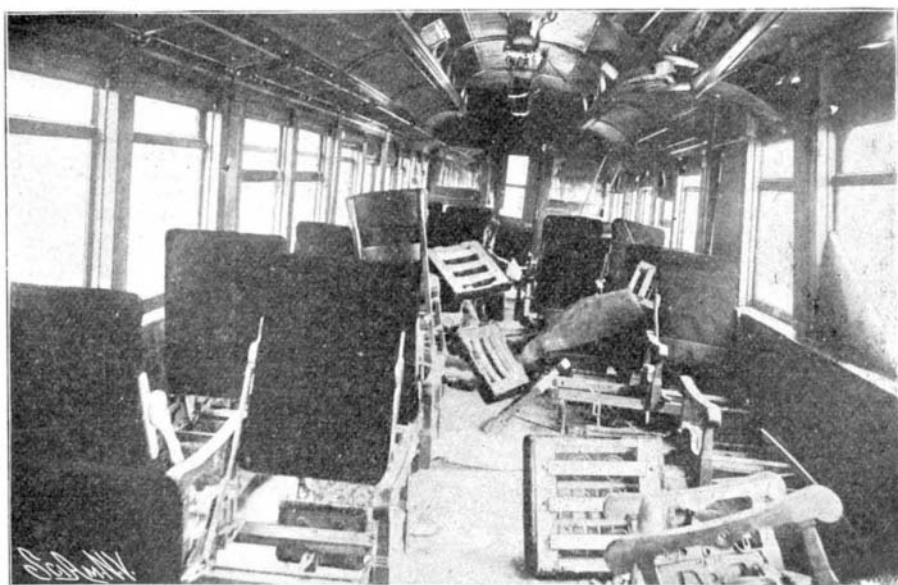
Interior of Chair Car After the Wreck.

The great strength of Pullman cars, as here demonstrated, is due to the excellence of the material of which they are built and the thoroughly scientific manner in which this material is disposed. To all intents and purposes a Pullman car is a trussed bridge, the two trucks being the piers or abutments on which it rests. Below the window sills within the outside sheathing is a stout steel and timber truss which extends for the full length of the car. The floor is also admirably adapted to withstand the shock of a collision, being framed of heavy longitudinal sills with steel plating sandwiched in between them. The latest cars have also steel framing at the corner posts and in the sides and roof. We are indebted for our illustrations and particulars to Mr. E. W. Hadley, of Santa Barbara.

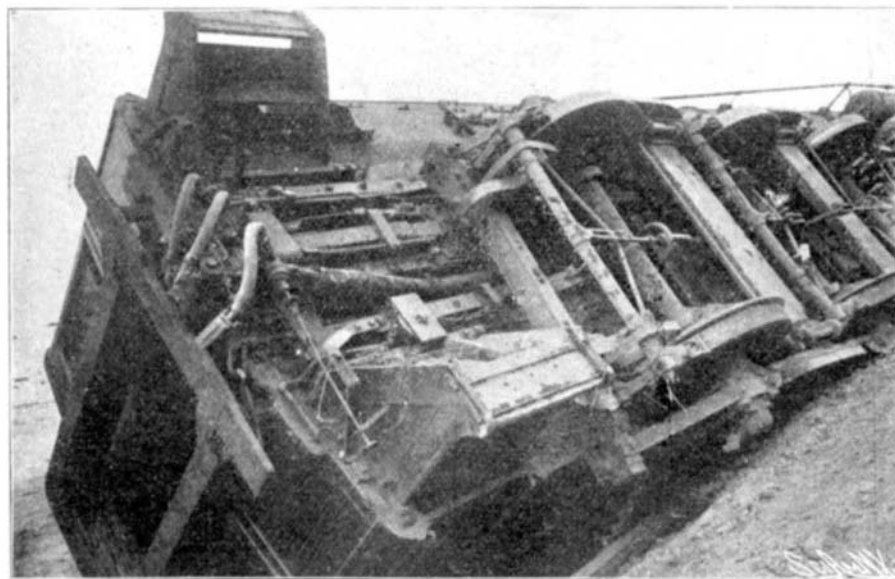
The Parlor Car, Bottom Side Up.
