BREAKAGE AND REPAIR AT SEA OF THE MAIN SHAFT OF THE STEAMSHIP UMBRIA.

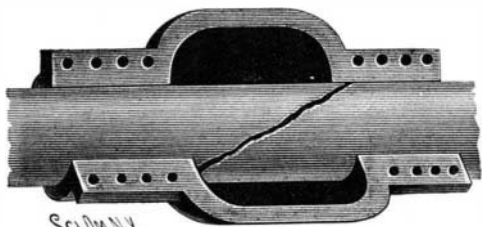
Fig. 7.

In this connection, we have thought it would be of interest to show how broken shafts are ordinarily repaired at sea. Most of the steamers carry on board what is called the Thompson coupling. (See Figs. 7 and 8.) This consists of three strong, flanged cylindrical sections of steel, which bolt together, and when thus combined they grasp and hold the broken ends of the shaft firmly together, as illustrated in Fig. 8. Fig. 9 shows how the Thompson coupling was success-
