### THE CONSTRUCTION OF THE ASYUT DAM; NILE IRRIGATION WORKS.

BY OUR LONDON CORRESPONDENT, FROM NOTES BY SIR BENJAMIN BAKER, ENGINEER OF THE WORKS.

# SCIENTIFIC AMERICAN

NEW YORK, FEBRUARY 28, 1903.

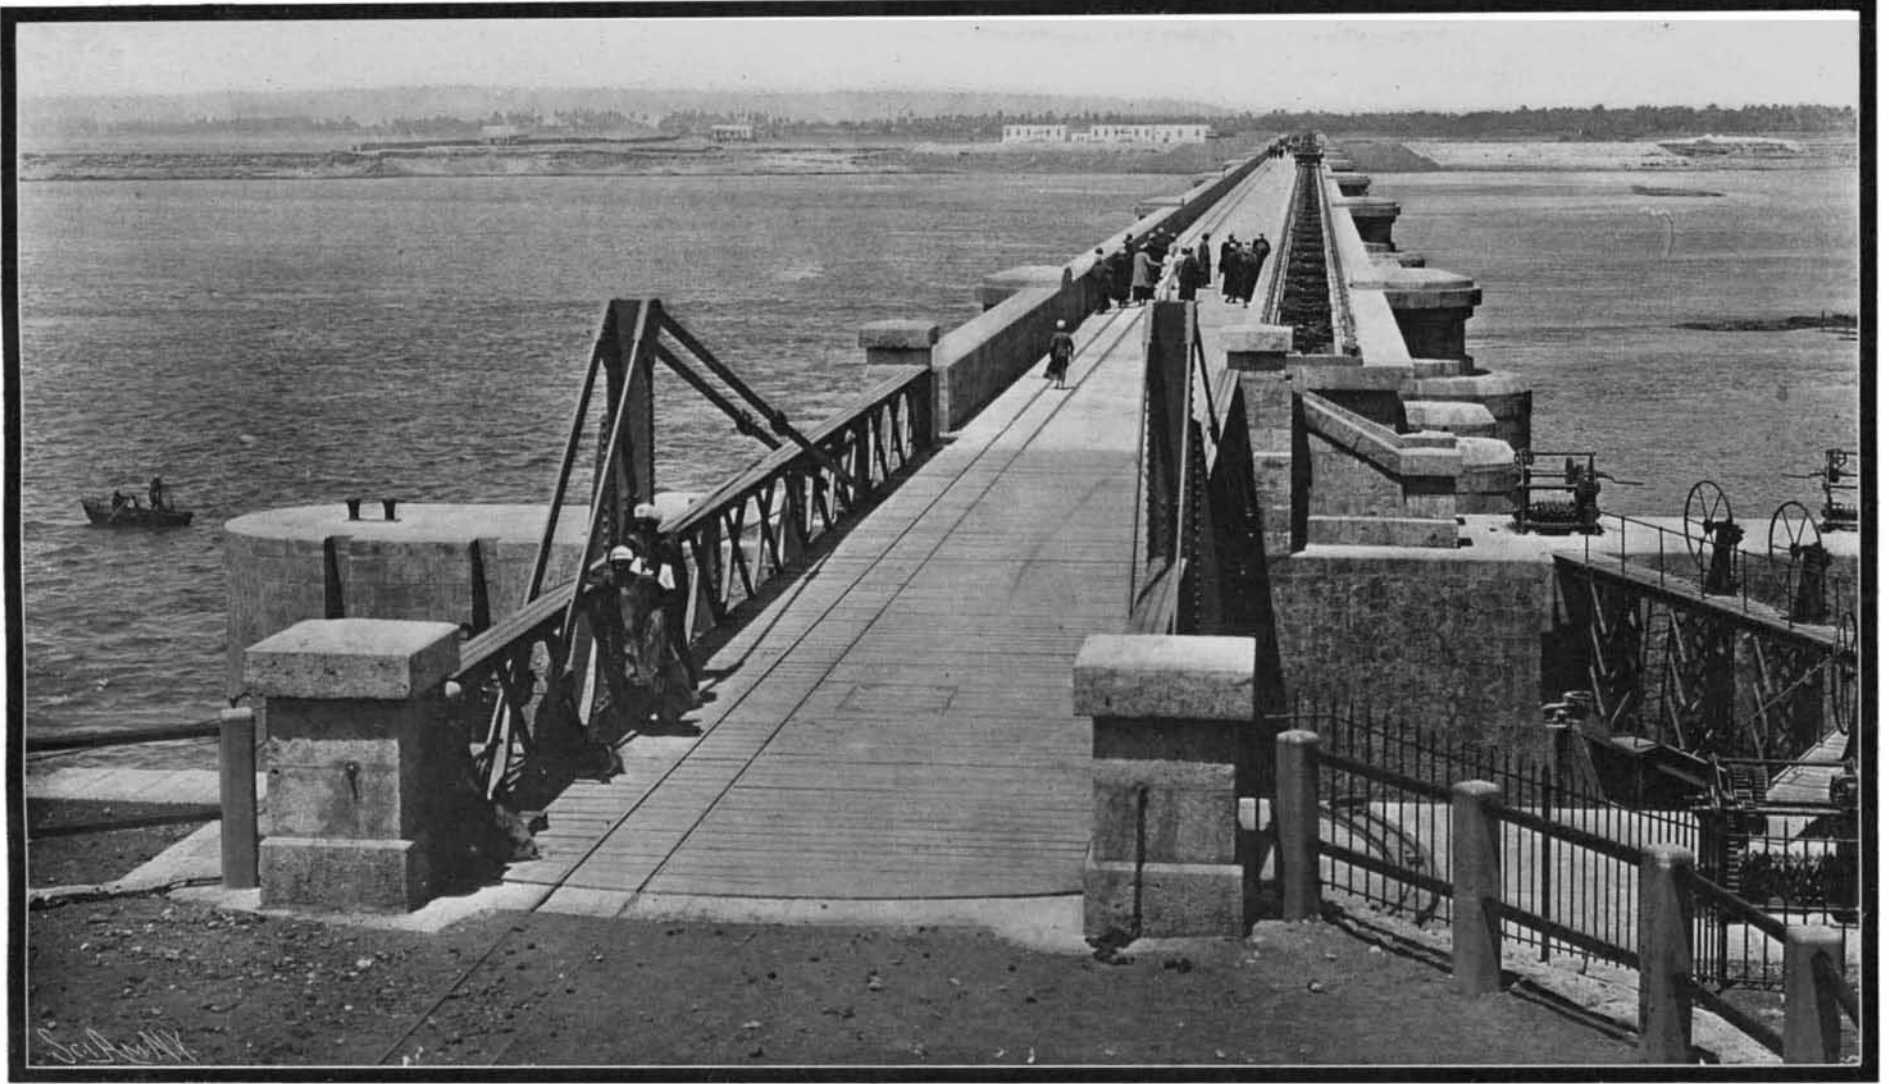
View Looking East Along the Roadway, showing Track for Sluice Regulating Gear.

The openings are each of 16 feet 4 inches span, and are each supplied with steel sluice gates 16 feet in height. At every ninth opening is built an abutment pier 13 feet in thickness, the intermediate piers being 7 feet, 6 inches thick. The piers are spanned by arches, and carry a roadway, 14 feet, 9 inches wide, at a height of 41 feet above the floor of the structure. This roadway not only affords communication between the opposite banks but, as will be seen from our illustration, carries the winches and suspension apparatus for regulating the sluice gates, which controlling machinery is placed on a trolley traveling along a railroad.

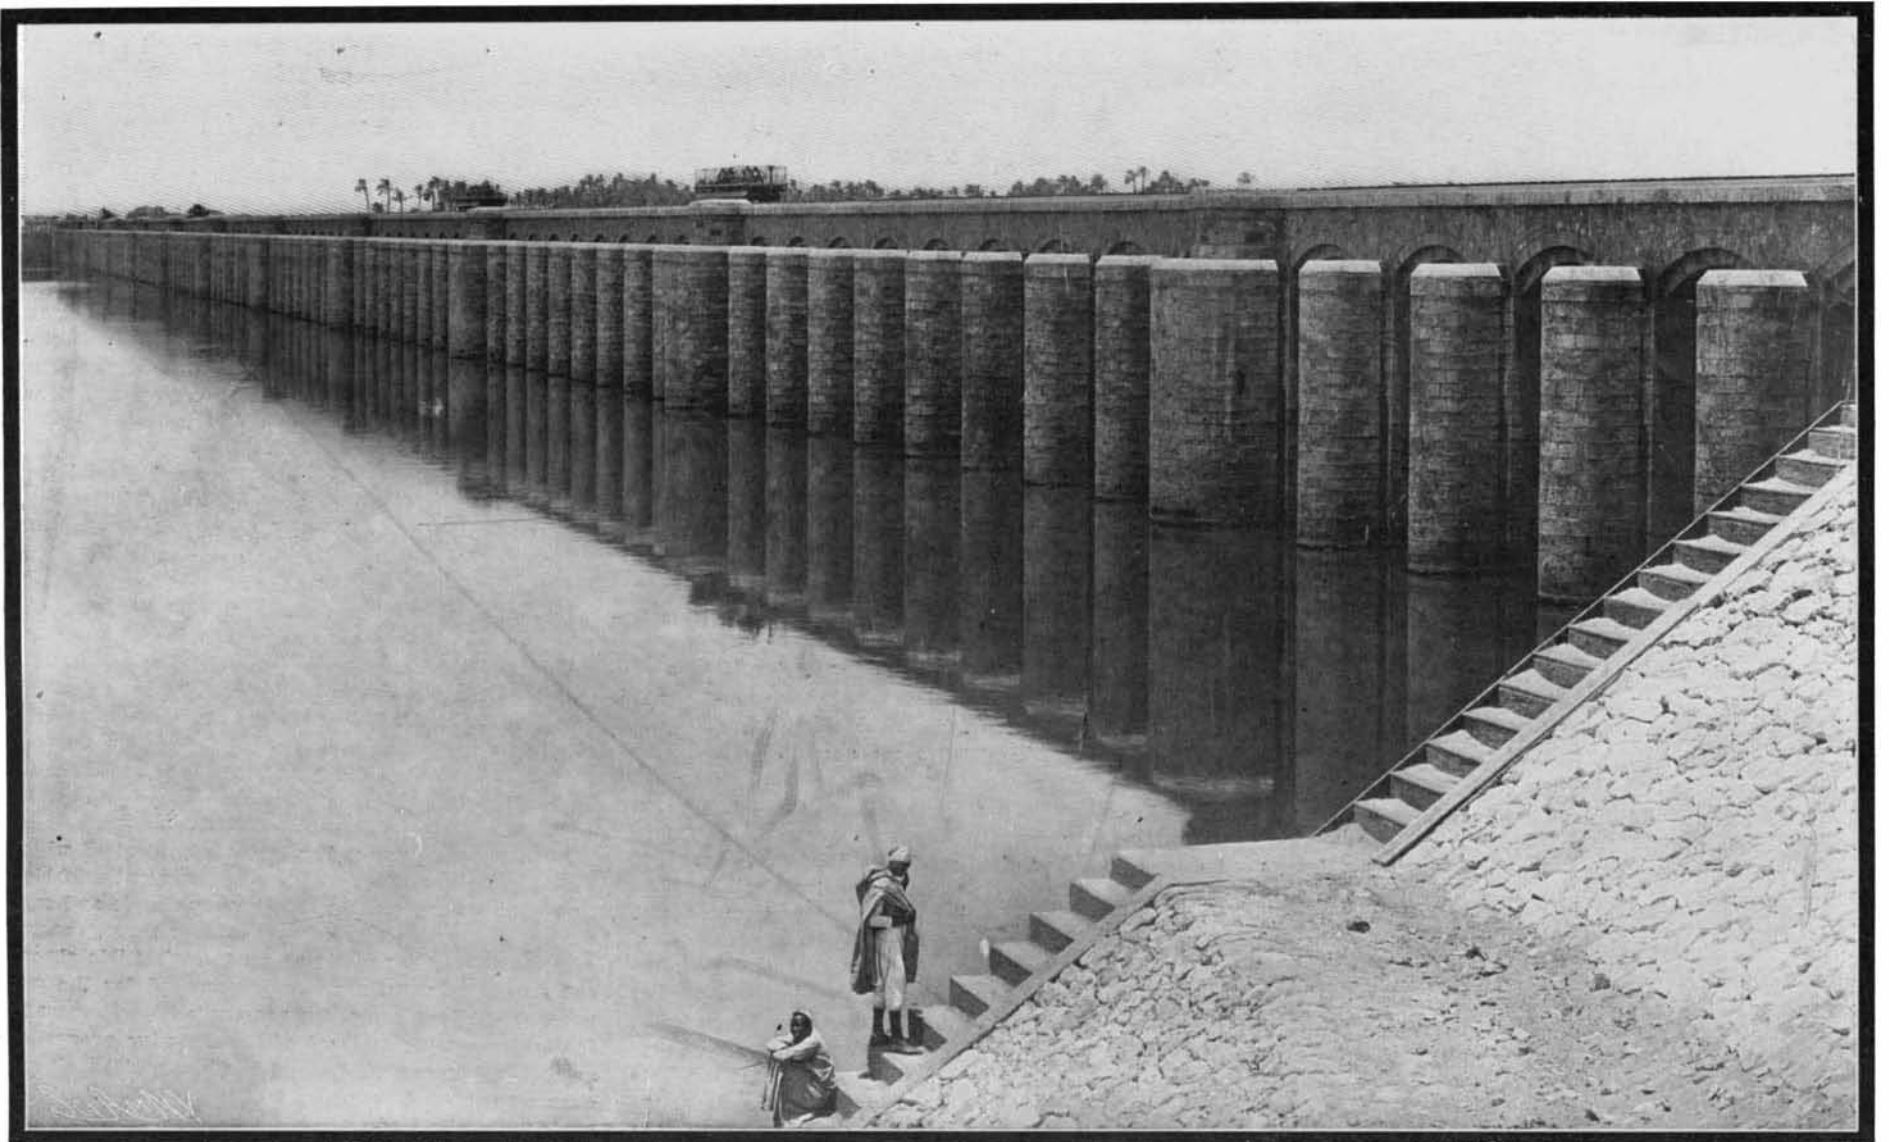
Asyut Barrage Across the Nile; Upstream Side Looking West.  
THE DAMMING OF THE NILE.—[See page 152.]

The structure built at Asyut differs in design from that erected at Aswan, having, as a matter of fact, a close resemblance to the barrage built by French engineers at the delta several years ago. It consists of an open weir of 111 bays, which has a total length of 2,750 feet from bank to bank.
